**Akamai Home Inspection Co. Inc.**  
P. O. Box 5397  
Kailua-Kona HI 96745  
329-5484  
akamaiinspection@hawaii.rr.com

**Report: 3Bd. 2 Ba Sample**

## **Confidential Inspection Report**

RE: Sunset Ridge - Waikoloa Village  
Waikoloa, HI 96738

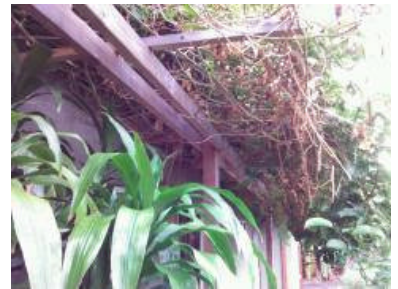
Partially Maintained, with plants against the house. Trim plants away from structure 24-36" Trees planted close to structure. Removal may be needed. Trees are touching or overhanging the roof. Damage is possible, cut trees back.

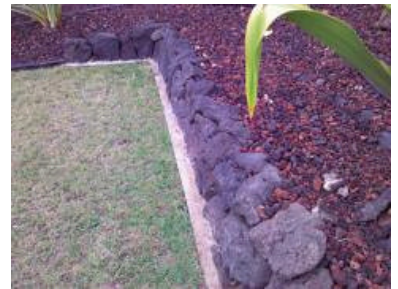
Retaining walls appear in good condition with no major cracks or heaving noted.

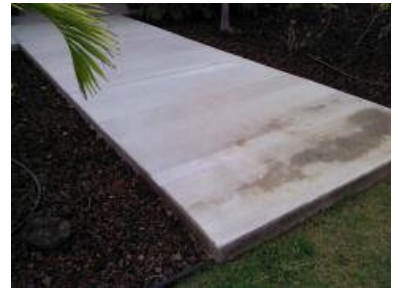
Appears satisfactory, good pour. No cracks noted.

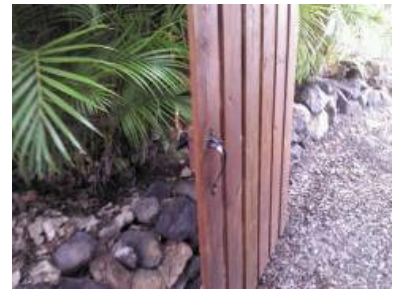
Satisfactory and good condition. Hinge hardware and latch are satisfactory.

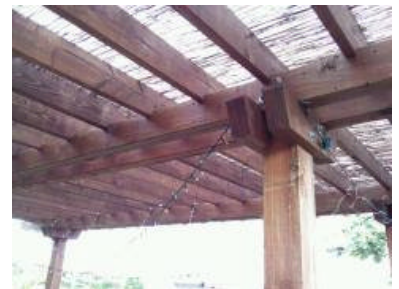
Trellis is a wood structure: Free Standing, with steel anchor post bases in place. Appears satisfactory, secure and solid.

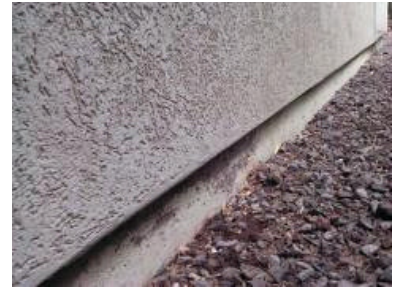
House and Garage are built slab on grade, typical in this area with rock sub grade.

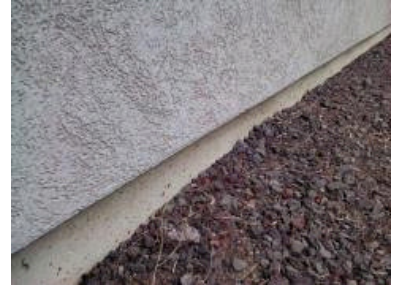
Slab Edge, good raised footing all around the perimeter walls. Appears satisfactory and sound.

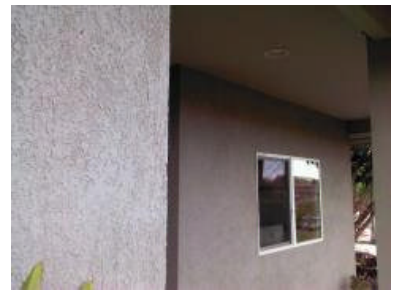
*CONDITION:* Appears to be in good condition, good surface finish.

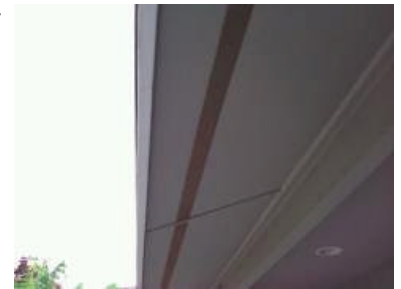
Satisfactory and good condition, no moisture wear noted.

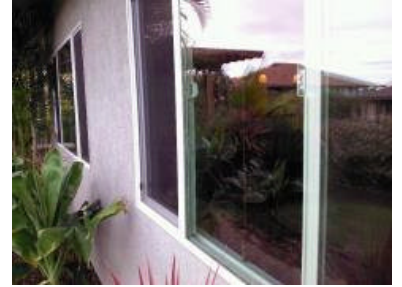
Good condition and operation, Good choice for this near ocean location.

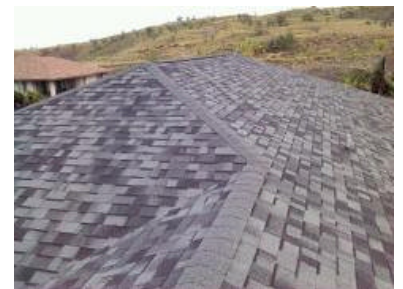
Condition is good. Layout and installation appears good.

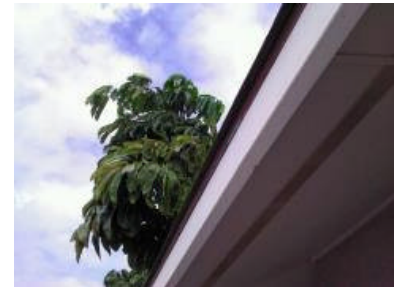
Good drip edge layout observed. Factory Painted Metal drip edge flashing all around the drip edges, quality added feature.

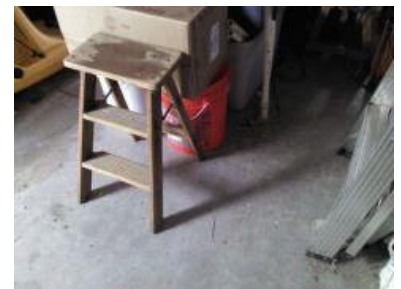
Appears satisfactory. Painted and clean, good condition. No cracks noted. Floor is not fully visible, due to stored items.

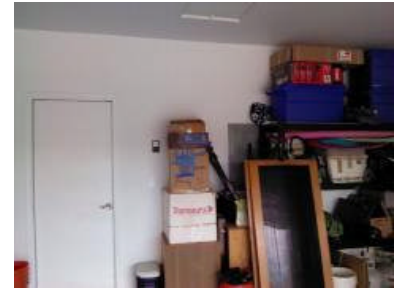
Appears satisfactory and serviceable, in general good condition, No holes or damage noted, Stored items prevents viewing of all wall areas.

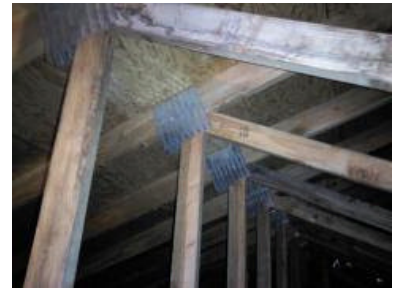
Satisfactory - The roof framing appears to be in functional condition.

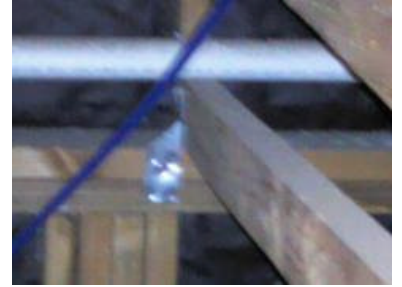
The roof structure appears very solid. Hurricane ties noted at truss connections, satisfactory instillation.

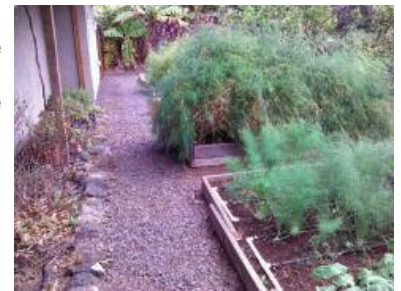
Waste line cleanouts are at east side of house indicating that Most likely under the vegetable planters. Cleanout caps not found, Review house plans, or Health Dept. records for accurate information.

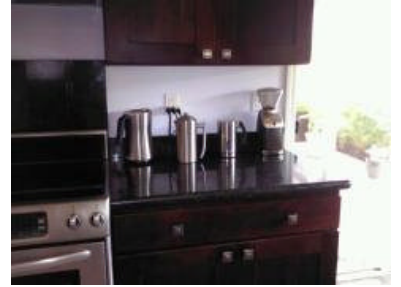
Appear satisfactory, no damage noted. Good for age, All shelves in place and satisfactory. Cabinet doors and drawers are satisfactory. Cabinets have minor surface wear.

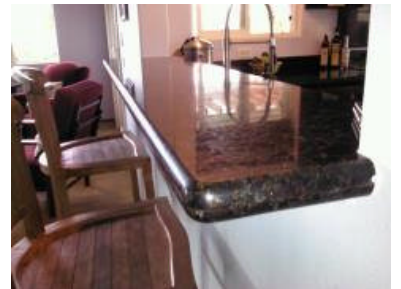
To prevent water stain damage to granite counters; Granite sealer and polish maintenance is recommended as a preventive maintenance program. Cantilevered extension at kitchen serving counter designed with no visible bracing, appears satisfactory.

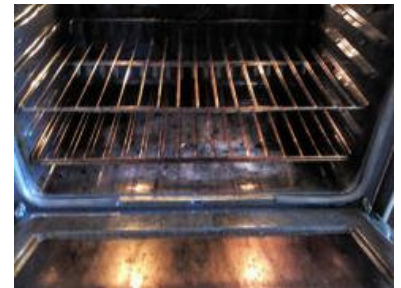
Operational and appears satisfactory, Oven needs cleaning.

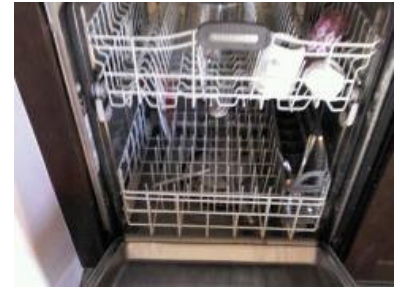
Appears satisfactory, operational and in good condition. Baskets in good condition, no rust.

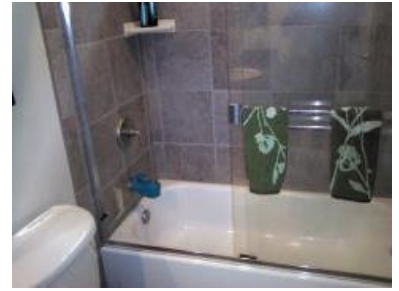
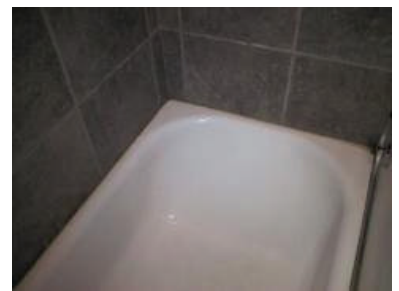
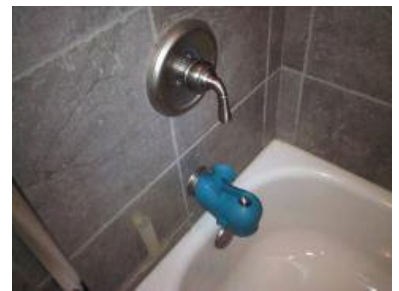
Tub and shower areas appear satisfactory. Tile appears good, taps solid. Tub shower walls are in good condition, no cracked or missing tiles, no tiles loose at walls.
