Report: Very Large Estate Residence Sample

Confidential Inspection Report

RE: Keauhou Estates
Kailua-Kona, HI 96740

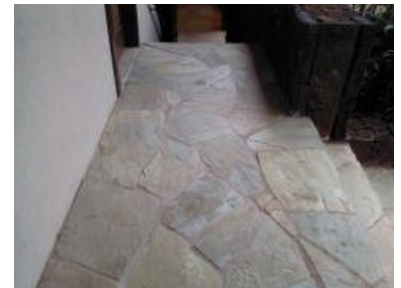
TYPE: Quartzite flagstone tile over concrete.

CONDITION: Good condition for age, no major defects noted, but staining present in several areas as disclosed. Power washing is needed for clean up.

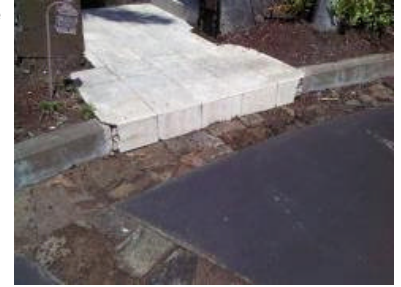
Walkway off the road entry, has damaged tile at the driveway edge. likely from being hit by car tires.

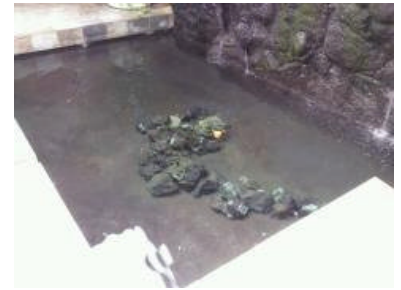
Location: Entry Courtyard. Cement in ground, reflection type pond. Not for fish at present, cleaned with chlorine.

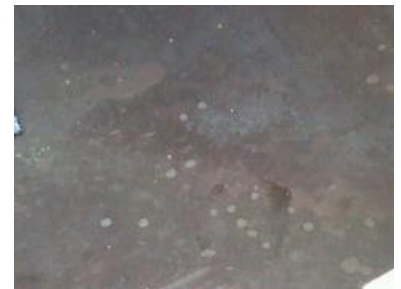
Spots in the pond are plaster pops. The surface color coat of the pond is worn out, time for a new plaster surface.

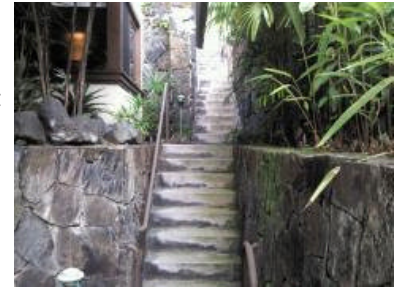
Three levels of Concrete stairs on the south side, good hand railings all along here. Some minor mildew growth noted, these stairs will likely need power wash periodically so they are not slippery.

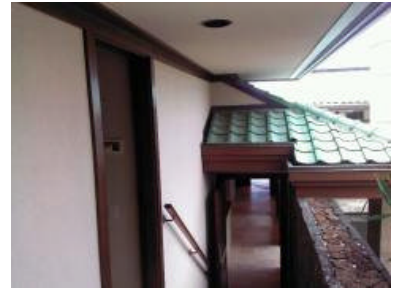
Hardwood trim throughout, and all around at the eave fascia.

Overall condition is satisfactory, but many areas show weather wear, with sun damage noted where exposed. Prep and Re finish maintenance is recommended in the near future, to protect the wood from further damage.

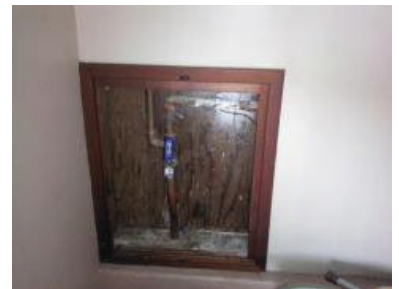
LOCATION 2: Secondary Main house Shut Off Valve is located in the garage, in the wall behind a small wood door.

CONDITION Valve is not operational, Excessive corrosion is found at the main valve. Broken handle. Maintenance is needed.

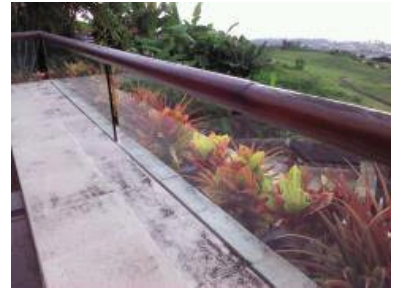
Short solid, tiled wall with glass panels and capped with wood railing.

Overall, satisfactory condition, Secure, Weather wear at the main lanai railing. Refinish maintenance is recommended.

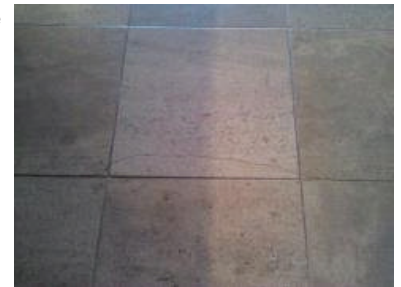
Appears satisfactory, condition good. A few hairline cracked tiles noted, as per disclosure.

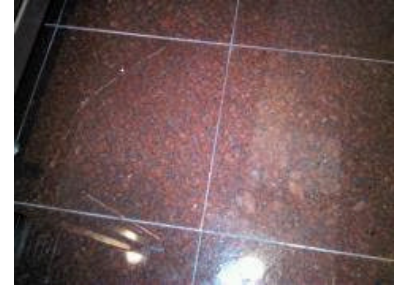
Marble tile with a couple of cracked tiles.

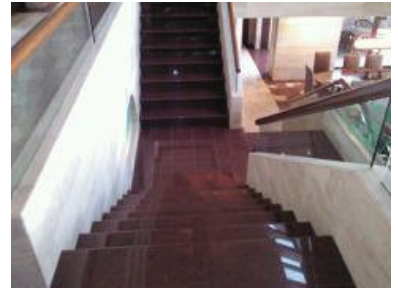
Interior stairs are in overall, good condition. Stair handrails are in good condition and secure.

Hallway stairs are in overall, good condition. Stair handrail is satisfactory and secure. A couple of hairline cracks noted at the granite slab steps. Safety lighting is operational, with double switching O.K.

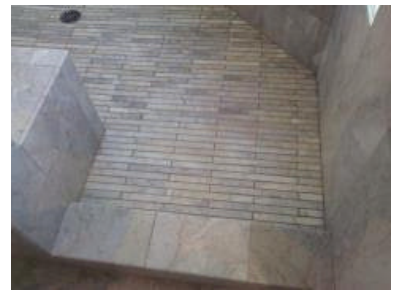
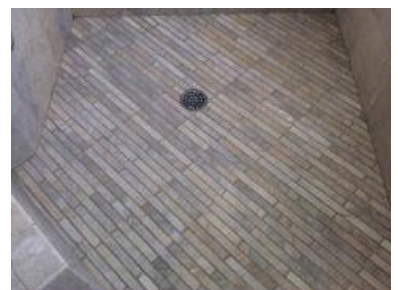
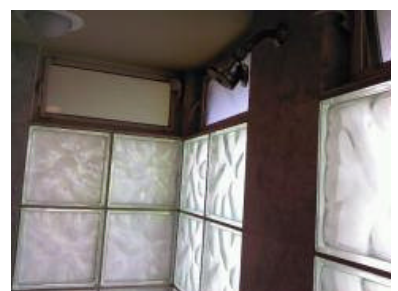
Shower areas appear satisfactory. Tile appears good, taps solid. Shower walls are in good condition, no cracked or missing tiles, no tiles loose at walls. Caulking and/or re-grouting is needed at the wall base around the shower pan to prevent water intrusion.

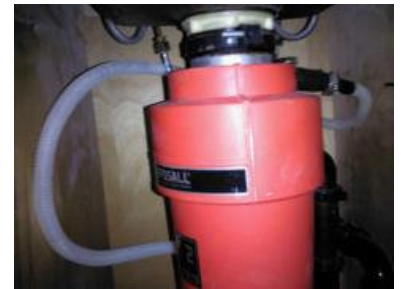
Operational and appears satisfactory, No rust at blade or sink connection. Disposal safety rubber boot is needed at the sink drain.

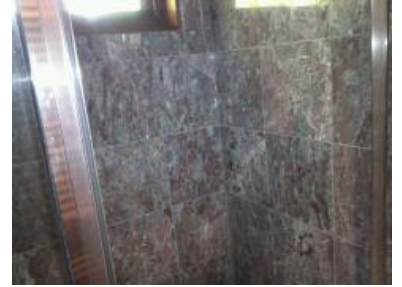
Caulking and/or re-grouting is needed to prevent water intrusion.

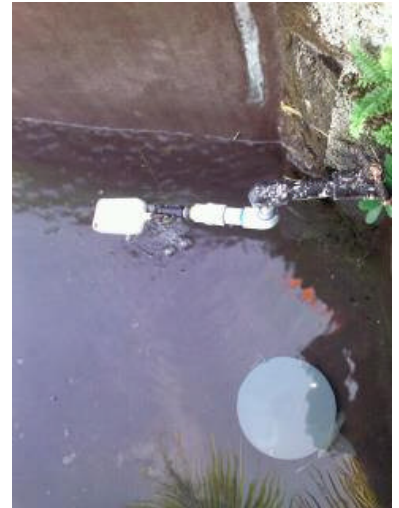
Float valve in the pool trough. The float valve filler is running continuously, maintenance or replacement needed.

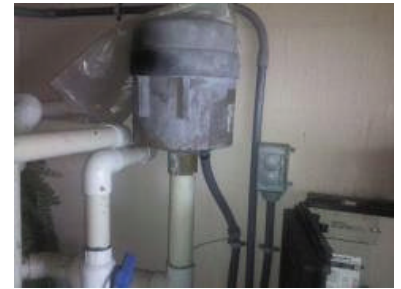
Disconnected, Not Functional.
