Report: Very Large Estate Residence Sample

Confidential Inspection Report

RE: Keauhou Estates
Kailua-Kona, HI 96740

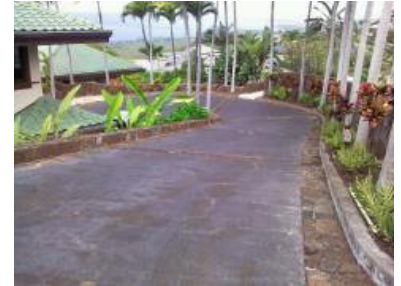
CONDITION: Good condition for age, Cracks noted are typical minor hairline type No lift or settlement seen.

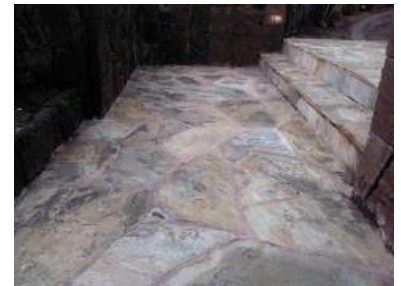
CONDITION: Good condition for age, no major defects noted, but staining present in several areas as disclosed. Power washing is needed for clean up.

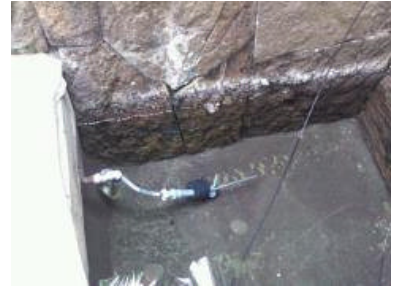
AUTO FILLER:

Comment: The Pond is set up with an automatic filler in place (toilet flow valve type), it is not operational, the valve is laying on the bottom of the pond, repairs needed.

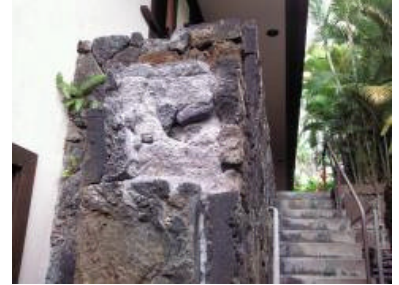
A few surface rocks are missing around the property, fallen out of the walls, and a few more are loose in the walls around the property. Overall the rock walls are in good condition, but could use masonry repairs to fix the few defects noted.

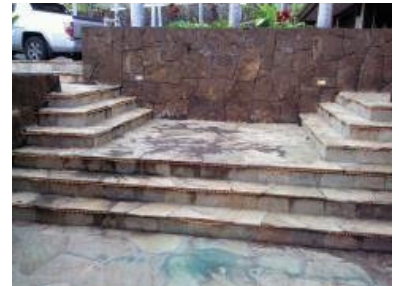
Front entry flagstone steps, with edge lighting, nice feature.

Staining evident per disclosure; power washing needed for clean up.

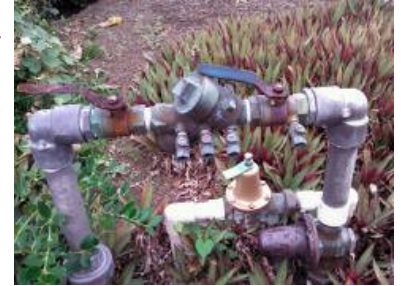
SHUT OFF & PR

Shut off, pressure regulator and back flow valve are at the supply stand. Valves and pressure regular are rusted and replacements are recommended.

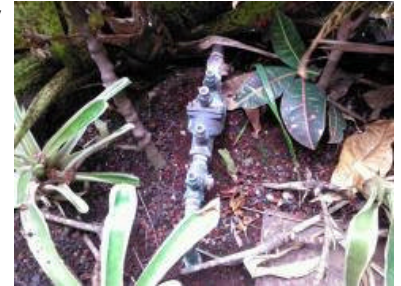
SHUT OFF & PR #2:

Shut off and back flow valve are at the supply stand. Located at the garage planter. Rust an broken off supply handles noted. Maintenance is needed.

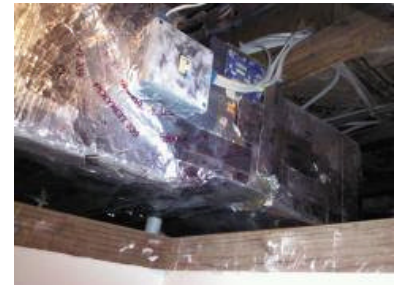
OTHER COMPRESSORS 2 WINE CELLAR: compressor/ air handler: Located in the media room closet attic. System is not cooling. Maintenance is needed.

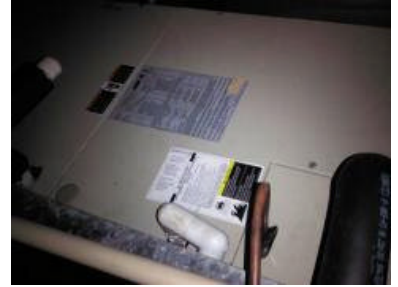
Guest quarters, upper bedroom adjacent to the garage, middle level bedroom lower bedroom, media room have satisfactory operation, with cold air produced (61-63°) at duct vents. Master suite and the office compressors do not produce cold air. Air handlers are operational. Recommend professional servicing of system, and checking refrigerant levels.

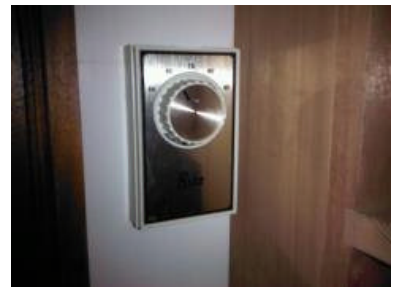
THERMOSTAT CONDITION #2:

Wine Cellar: "Beko brand thermostat control is not functioning correctly, did not turn off the chiller system. I switched off the service disconnect in the attic, at the unit.

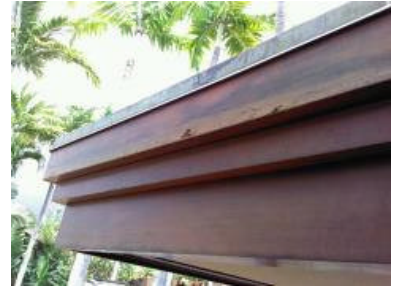
Overall condition is satisfactory, but many areas show weather wear, with sun damage noted where exposed. Prep and Re finish maintenance is recommended in the near future, to protect the wood from further damage.

Note: The Hardwood trim, and exterior doors have a Sikens type finish. Much of this wood finish is exposed to weather, Sikens is a high quality material to protect the wood. Note: Expect refinish maintenance every few years for quality upkeep due to the near location to the ocean, and high UV of the sun in Hawaii.

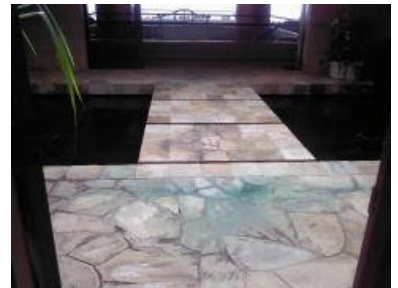
EXTERIOR FLOOR:

Quartzite flagstone. Staining from copper rain runoff, and water pooling as per disclosure. Power wash clean up needed.

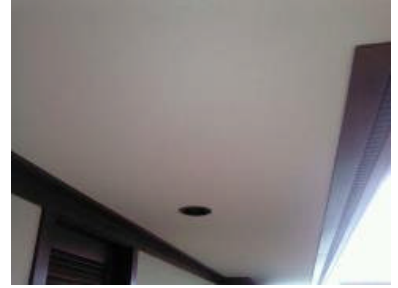
Stucco, Soffit all around.

Satisfactory and good condition, No moisture wear noted, No mildew/fungi growth.

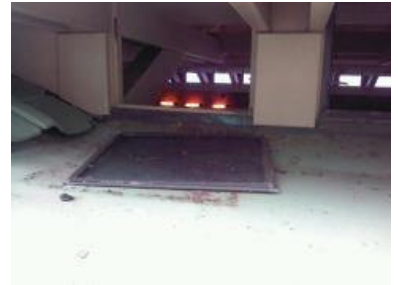
One window screen re installation needed above the front entry, at the SE corner of the living room roof. There are upper screened ventilation windows all around the living room.

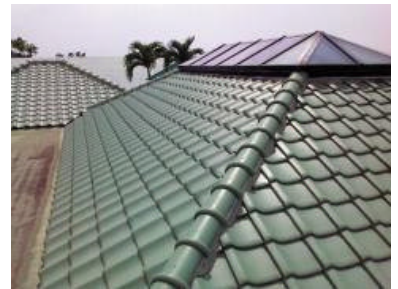
CONDITION: Condition is overall very good, Layout and instillation appears very good. No major defects noted. Only a few cracked tiles noted. As per disclosure, tile roof repairs were done in 2010 as normal preventive maintenance. There are spare roof tiles in the outside closet behind the garage.

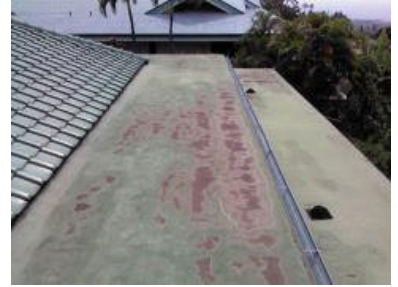
Original roofing, satisfactory condition for age, but showing weather wear, especially at the spots that water pools. Maintenance re sealing repairs are recommended as preventive maintenance.

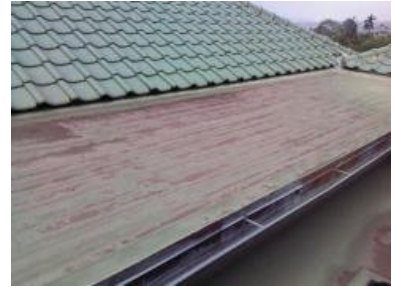
Original roofing, with weather wear typical for age. flat roofing appears to be near the end of its useful life. Time to re seal these flat/ low pitch roof areas.

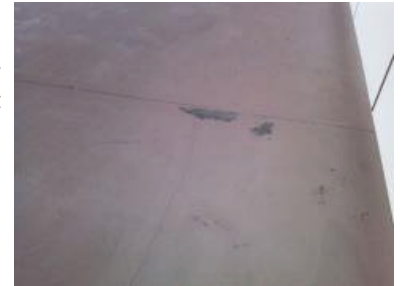
Typical minor hairline curing cracks noted. These do not appear structurally significant. No lift or settlement noted. Appears satisfactory. Painted and generally clean, but with some paint chipping typical for age.

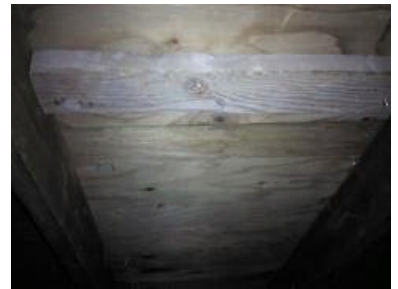
The roof decking material is plywood sheeting. Blocking used as ply clips.

The roof structure appears very solid. No Hurricane ties at rafter/wall connections, steel ties could be Retro fitted.

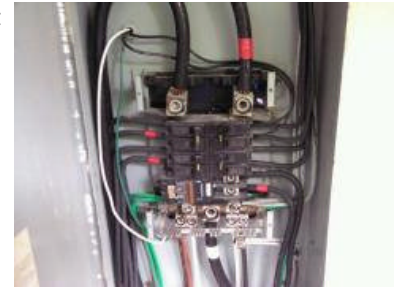
Underground, 400 AMP, Three wire, multi-circuit breaker service. AWG wire size to panel is adequate.

Appears satisfactory and serviceable, Layout and condition good. Main Breakers appear satisfactory.

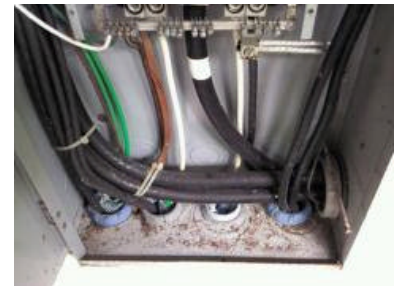
Grounding system is present and appears O.K. UFER ground to slab.

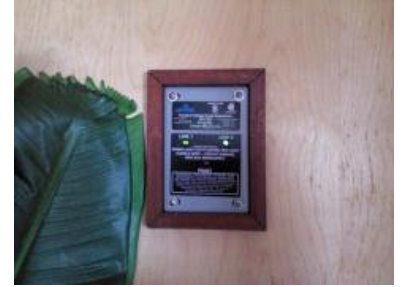
Also a GE surge protector in place, and operational.
located in the garage interior closet.

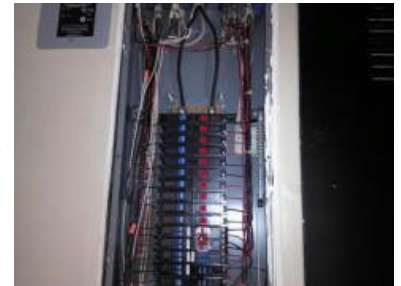
Panel front condition is satisfactory, Layout and condition is very good, clean within the panel housing. All copper wiring at 110V circuits, No loose wires and no evidence of any arching. No visual evidence of excessive heat, or heat related damage. No double taps at circuit breaker lugs.

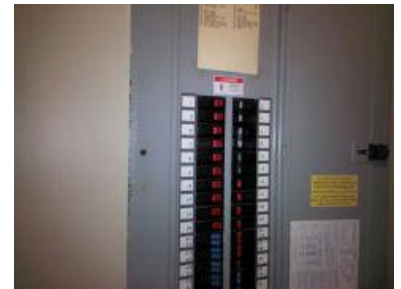
Hall closet.

Panel front condition is satisfactory with some light surface rust, that could use some prep and paint maintenance Layout and condition is good, clean within the panel housing. All copper wiring at 110V circuits, No loose wires and no evidence of any arching.

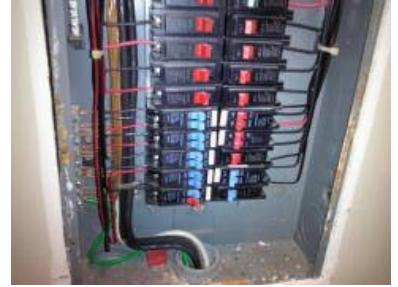
Circuit and wire sizing correct so far as visible. Panel is Full. Layout labeling is present. Grounding is present. Good circuit distribution. All 220 volt breaker ties are satisfactory.

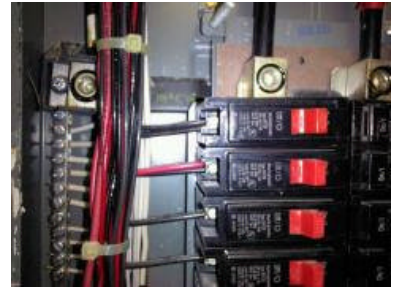
Panel front condition is satisfactory, Layout and condition is very good, clean within the panel housing. All copper wiring at 110V circuits, No loose wires and no evidence of any arcing. (2) double taps noted for the light touch panel lighting circuit, typical for time built.

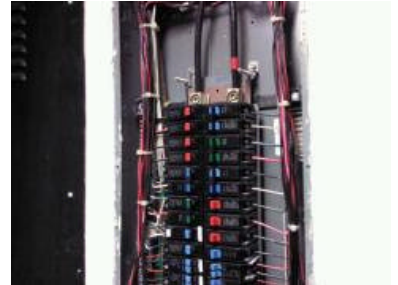
Circuit and wire sizing correct so far as visible. Panel is Full. GFCI safety breaker(s) at the sub panel test O.K. Layout labeling is present. Grounding is present. Good circuit distribution. All 220 volt breaker ties are satisfactory.

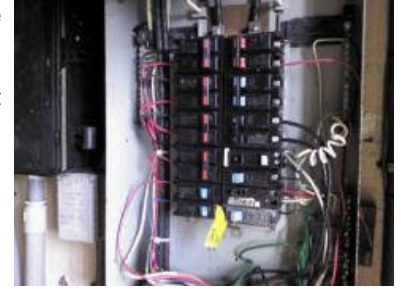
Layout and condition is very good, clean within the panel housing. All copper wiring at 110V circuits, No loose wires and no evidence of any arching. No double taps at circuit breaker lugs, Panel front condition is satisfactory, with typical light surface rust.

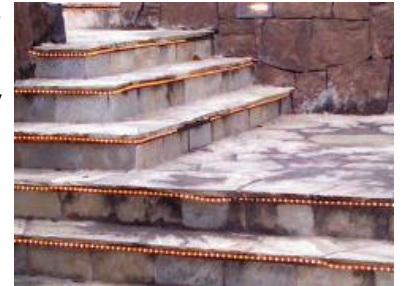
Exterior outlets are satisfactory and in serviceable condition. GFCI outlet is operational, Proper exterior outlet covers in place. Lights are not operational in some areas, possibly due to bad bulbs.

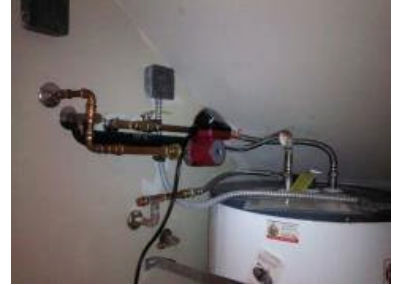
Shut off valve, operation and condition is good. Plumbing connections are O.K., no corrosion. Pressure relief valve is operational and in good condition.

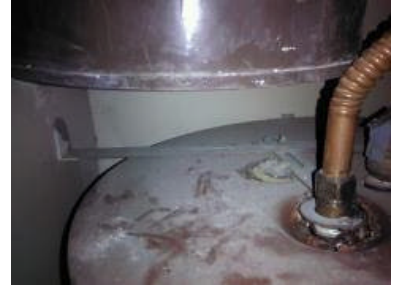
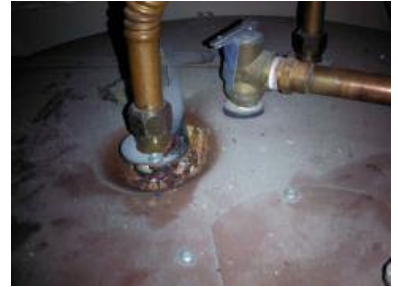
Older appliance, Original, time for replacement.

Serviceable for age, but time for replacement. as preventive maintenance.

Shut off valve, operation and condition is good.
Rust/ Corrosion at the plumbing connections, poor condition. Pressure relief valve is frozen, poor condition.

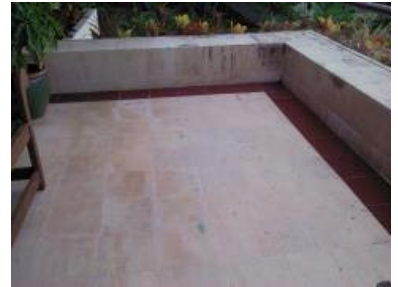
Tile is weathering from sun and rain. Stone sanding and polishing is needed for these exposed locations.

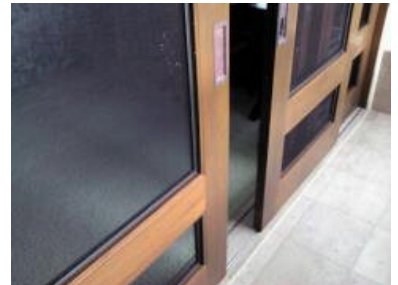
Main lanai with none - Island Style. Bedroom Lanai's with wood framed double sliding screen doors. Good condition. Downstairs with hideaway wood framed sliders in overall, good condition.

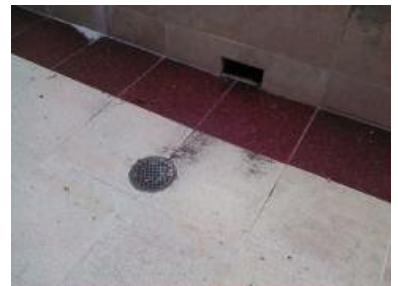
Good slope away from the structure, scupper drainage system in place.

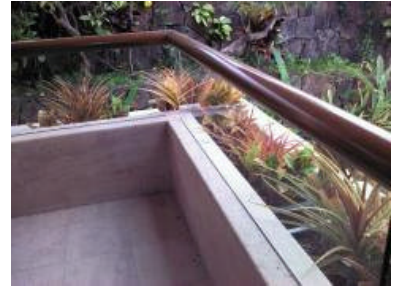
Overall, satisfactory condition, Secure, Weather wear at the main lanai railing. Refinish maintenance is recommended.

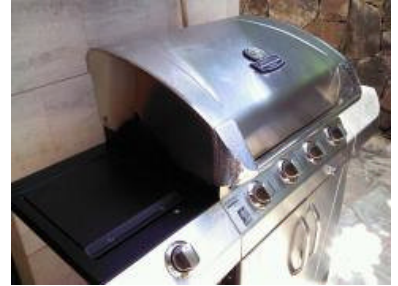
LP Gas Grill: Stainless Steel. Char-Broil. Electric igniter is not functional, need maintenance repair. Hand held lighter used.

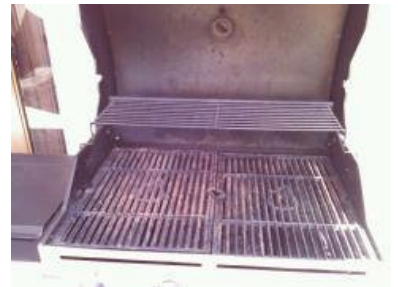
Satisfactory and generally clean, with some typical usage wear. Operational.

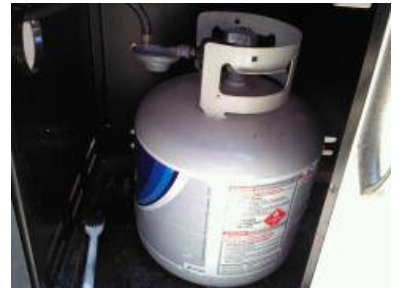
Gas Supply: 5 Gallon tank in place. In vented cabinet, OK.

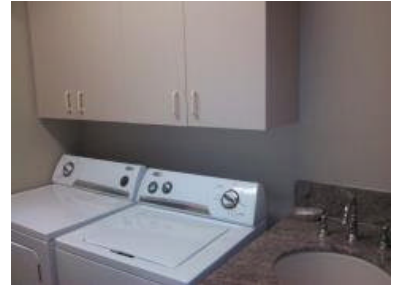
Clean and in good condition. Plumbing appears O.K. No Leaks or moisture damage noted. Electrical outlet is grounded. 110V circuit in place-operational, 220V circuit in place, Service-operational.

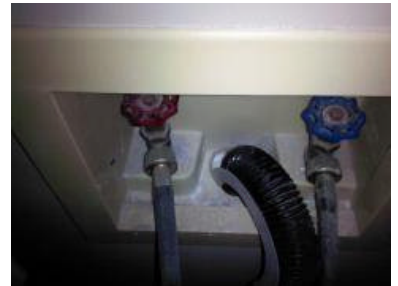
Drain line is at Wall drain box. Hose is secured and satisfactory.

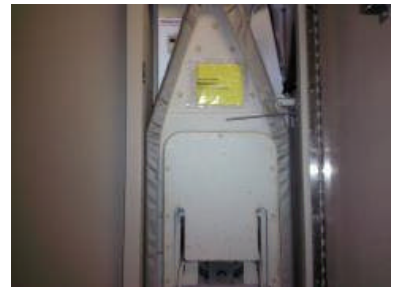
Supply valves appear O.K. No leaks or major corrosion.

Light is operational, fixture O.K. Wall mount ironing center in place. Appears satisfactory, outlet OK. Quality Cabinets in place, good condition.

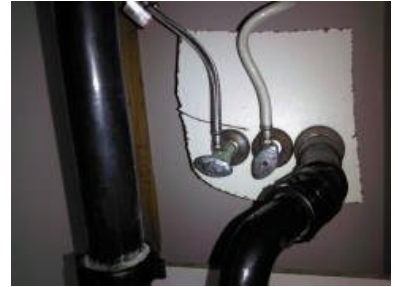
Laundry sink and plumbing are in good condition, clean and dry under sink. Faucet operation is O.K., no leaks. Hot & Cold OK.

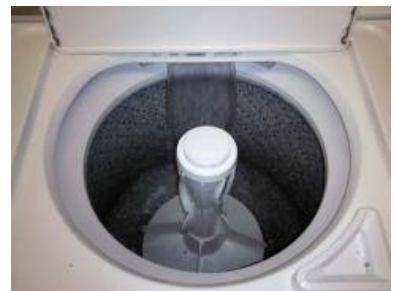
CLOTHES WASHER CONDITION: Appears satisfactory, clean, operation good.

I recommend monitoring the washer hoses, and replacing with new hoses every 5 years as preventive maintenance.

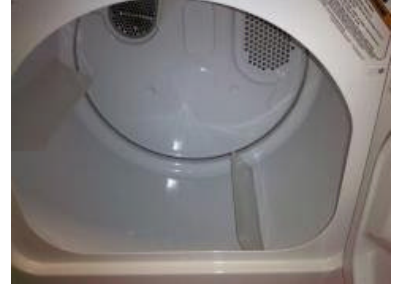
Appears satisfactory, operation is good, Unit is clean.

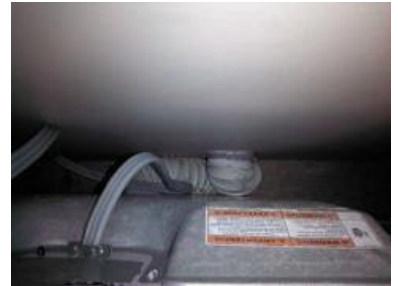
Dryer venting is provided, Through wall, Vent hose is in place and connected, and appears in good visual condition. Good exhaust.

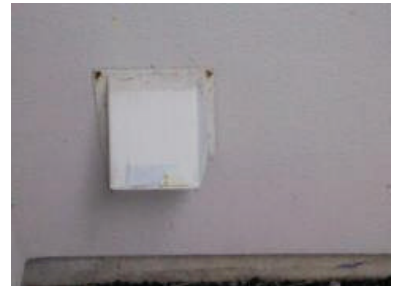
Appears satisfactory, At outside wall.

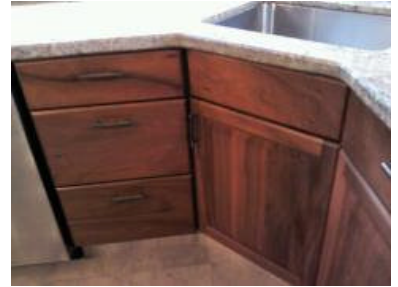
CONDITION: Good for age, with minor typical wear. All shelves in place and satisfactory. Cabinet doors and drawers are overall, in good condition.

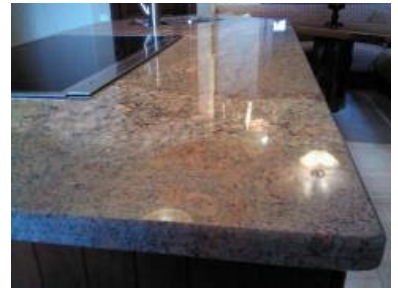
COUNTER TOP CONDITION: Good quality and condition. Layout and instillation is very good, no damage noted.

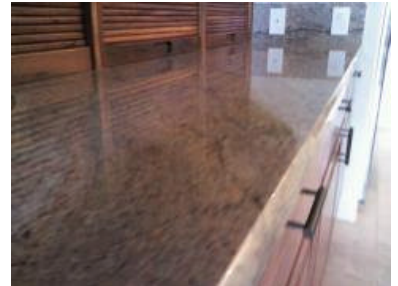
COUNTER TOP NOTE: To prevent water stain damage to granite counters; Granite sealer and polish maintenance is recommended as a preventive maintenance program.

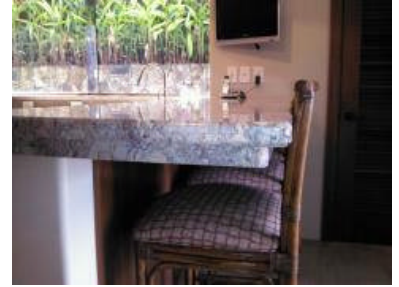
Cantilevered extension at kitchen serving counter designed with no visible bracing, appears satisfactory.

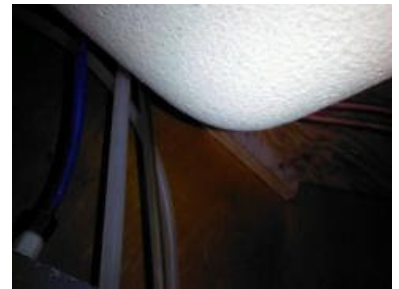
Appears satisfactory. No rust at sink edge or under sink. Minor wear noted. No moisture under the sink edge. No rot under the sink edge. Drainage O.K.

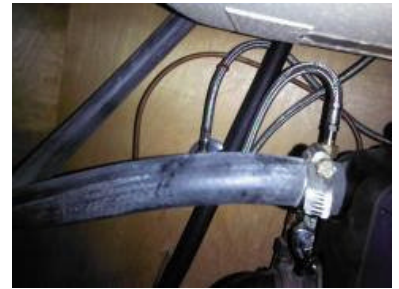
Plumbing condition is good. Dry and clean under the sink. No leaks noted or present at time of inspection with water flow testing at the supply valves, lines, at both sink connections, sink traps or waste lines.

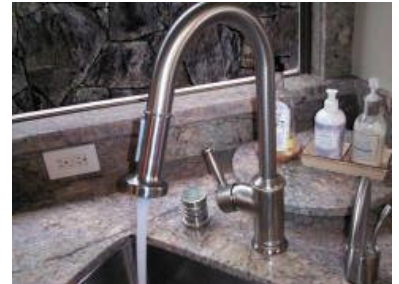
Pull out with sprayer feature, Swivel, Faucet: is satisfactory and in good condition. Hand sprayer is: operational and in good condition.

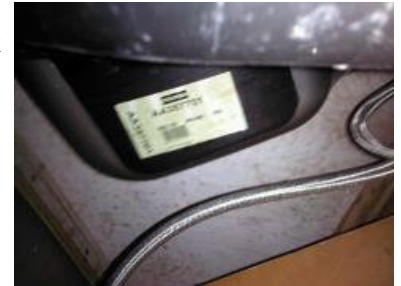
SINK 2 CONDITION: Good quality under counter mount prep sink:-)
Appears satisfactory. No moisture under the sink edge. No rot under the sink edge. Drainage O.K.

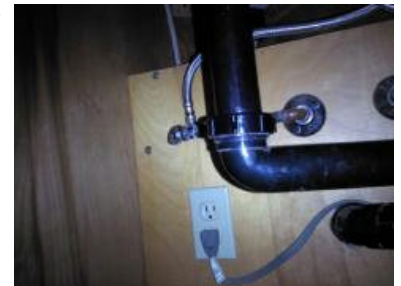
SINK 2 PLUMBING: Plumbing condition is good, Dry and clean under the sink.

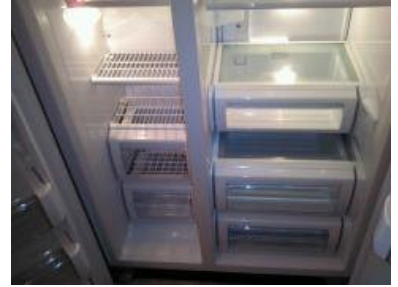
CONDITION:

Not operational. As per caretakers disclosure, scheduled for repair. Unit needs to be tested. Clean, shelves in good condition. Door gaskets are satisfactory.

Test icemaker after repairs.

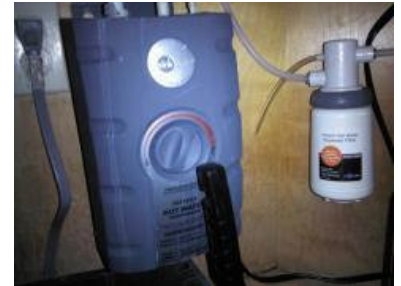
INSTANT HOT WATER DISPENSER:

Not producing hot water. Maintenance is needed.

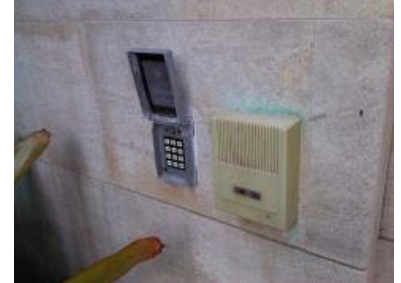
BELL:

Security keypad and intercom system in place. Inquire for the gate code to operate. Intercom did not function when tested. No phone available.

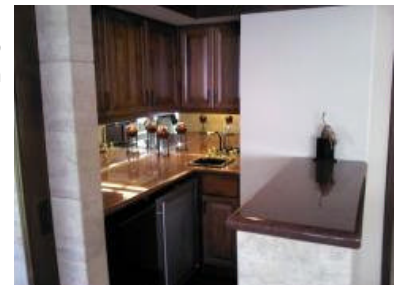
Upstairs, outside the master suite. Wet bar with custom cabinets, marble tile floor, marble slab counter tops and mirrored wall splash. Overall, in good condition.

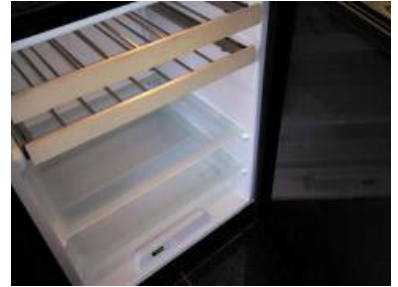
FRIG CONDITION: Operational, cold inside. Condensation between glass door panels. The gasket appears to be compromised allowing condensation to enter between the panes.

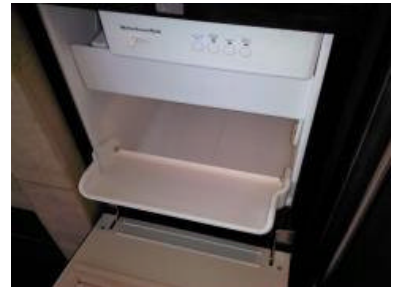
ICE MAKER: Kitchen Aid. Unit is not cooling. Maintenance is needed, inquire with an appliance specialist.

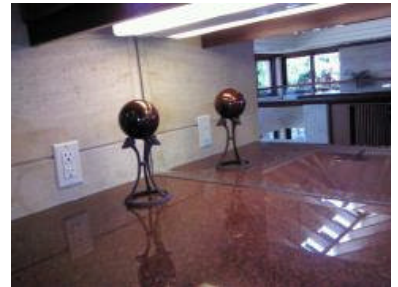
Light is satisfactory, operation O.K. Under cabinet light, Functional.

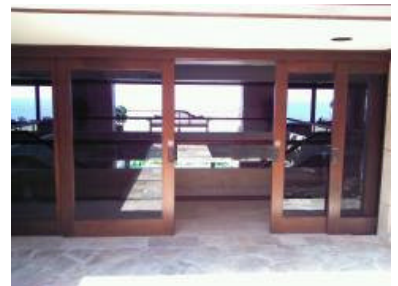
Main entry both front and side courtyard doors are; Custom quality, Hardwood framed, multi panel hideaway glass doors with custom wood framed multi hideaway sliding screen doors.

MAIN DOOR CONDITION: Satisfactory, hardware in good condition. No corrosion, Track and frame are satisfactory, no corrosion. Latch and handle are O.K.

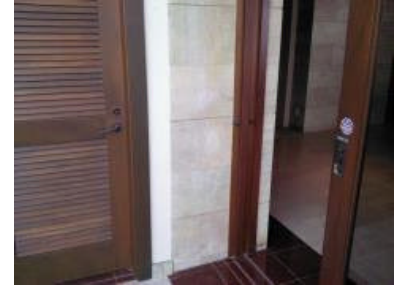
Swing louvered style, solid side doors and single wood framed, sliding glass doors.

Satisfactory, hardware in good condition. No corrosion, Track and frame are satisfactory, no corrosion. Doors are easy to operate, slide well. Latch and handle is O.K. Door stops in place and functional.

Normal Track lubrication maintenance recommended for the heavier sliding glass doors, which should allow for continued easy operation. Periodic Silicone spray applied to the tracks recommended for this location.

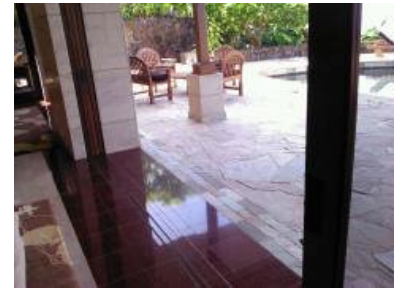
Living room and upper doors to Lanai area; Custom quality, Hardwood framed, multi panel hideaway glass doors.

Satisfactory, hardware in good condition. No corrosion, Track and frame are satisfactory, no corrosion. Doors are easy to operate, slide well. Latch and handle is O.K. Door stops in place and functional.

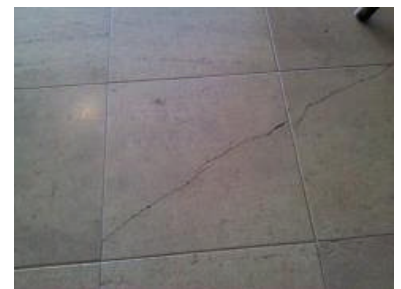
Layout of tile is good, Tile taps solid, with random tap test, Good quality. Tile taps solid in the areas of cracked tiles.

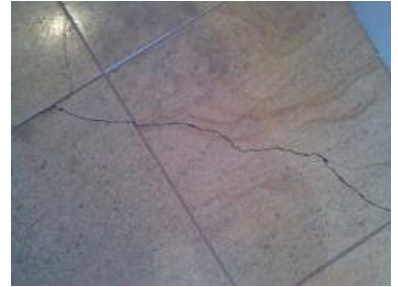
AS PER DISCLOSURE; Many cracks in the stone tiles throughout some are larger than hairline cracks. These are most likely movement cracks from several earthquakes over the years. They do not appear structurally significant and some can possibly be cosmetically patched to blend in with the natural stone appearance. Inquire with a stone tile specialist.

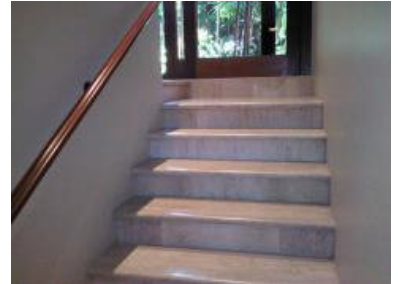
Hallway stairs are in overall, good condition. Stair handrail is satisfactory and secure. A couple of hairline cracks noted at the granite slab steps. Safety lighting is operational, with double switching O.K.

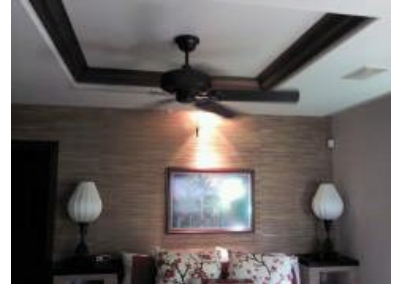
Fans OK, Operational and balanced. Middle guest bedroom fan's pull chain switch is not functioning correctly. Maintenance replacement switch is recommended.

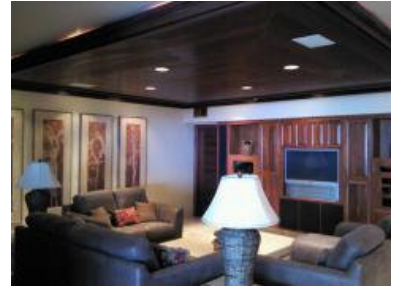
Entertainment Room: nice quality added wall cabinets. electrical, ceiling and walls appear to be in very good condition, consistent with the bedrooms. tile floor cracks noted as per disclosure.

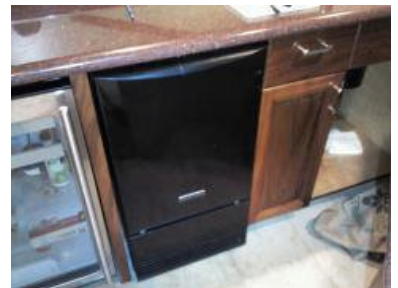
ICE MAKER: Not operational, did not turn on, not functional.

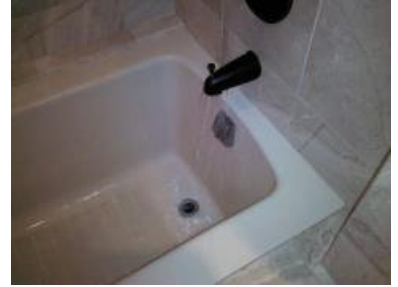
Fixtures are satisfactory and hardware is in good condition. Drainage is normal and adequate. Condition of tub spout: Tub spout is in good condition, and operational. Shower head appears serviceable. Tub drain stopper, is not functional, damaged, or missing.

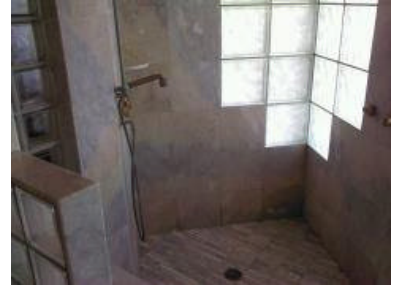
Shower areas appear satisfactory. Tile appears good, taps solid. Shower walls are in good condition, no cracked or missing tiles, no tiles loose at walls. Caulking and/or re-grouting is needed at the wall base around the shower pan to prevent water intrusion.

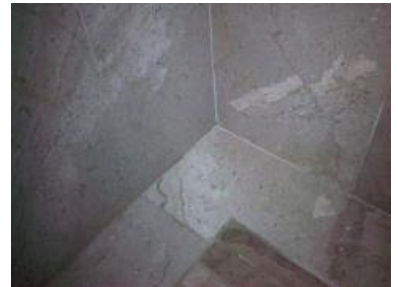
Shower walls are in good condition, no cracked or missing tiles, no tiles loose at walls. Caulk and seal the wall base of shower area as a precaution.

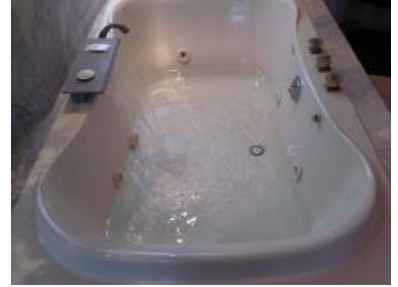
Drainage is normal and adequate. Tub drain stopper, is not functional, damaged, or missing. Rubber plug being used. Condition of tub spout: Tub spout is in good condition, and operational. Appears serviceable. Drainage is normal and adequate. Sprayer has mineral deposits and needs cleaning.

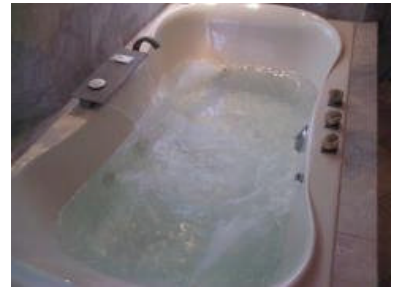
None provided, missing. Most likely behind the tile wall. Hatch needed for access to spa equipment.

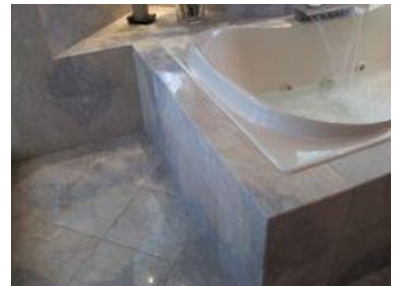
Chrome fixtures. Shower Valve is not operational.
Maintenance is needed.

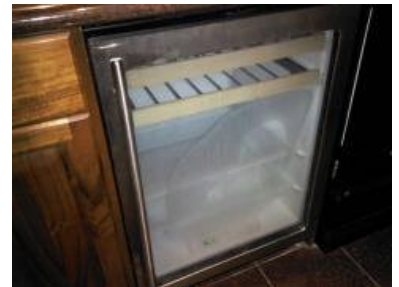
TYPE AND CONDITION: Electric. Operational, cold inside. Condensation between glass door panels. The gasket appears to be compromised allowing condensation to enter between the panes.

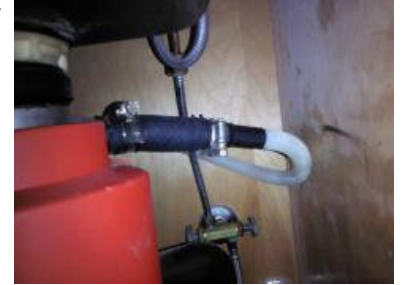
A proper air gap is Not installed in the dishwasher drain line. High-loop is recommended on drain line as an option.

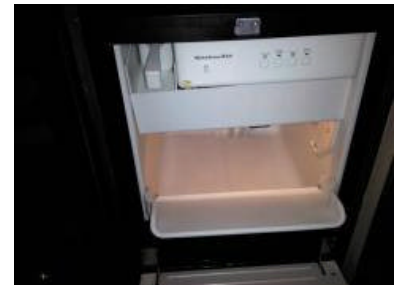
SEPARATE ICE MAKER:

Ice maker is not operable. Not cooling. Maintenance is needed.

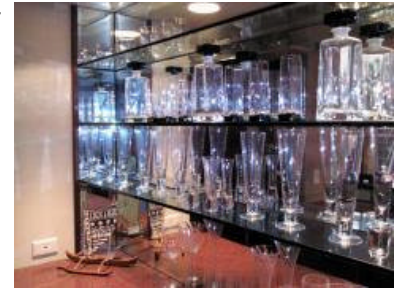
WALLS

Drywall, Clean and good condition. Full mirrored bar shelves in good condition.

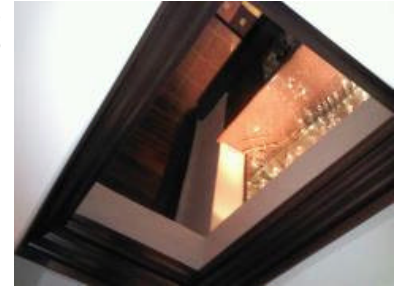
CEILING

Drywall, Clean and good condition. No moisture wear or damage. Mirrored ceiling feature appears to be in good condition. A nice feature.

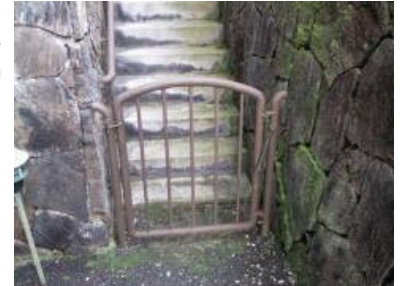
GATES:

TYPE: Painted steel gate creates access to the pool area on the south side at the bottom of the stairs. Self Closing, In Place, and operation satisfactory. Also two steel gates provide access below the pool at both the north and south sides. These gates are all the same, and in good condition for age.

Appears serviceable, satisfactory. Gates are in good condition for age, latch and hinge hardware OK. Lower gates could use paint maintenance.

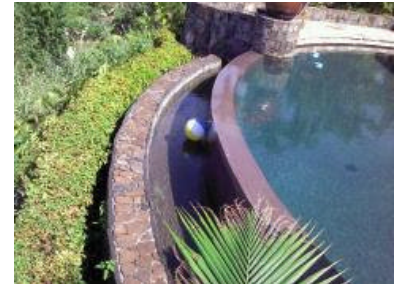
INFINITY EDGE:

Operates with the pool filter. Note: The water level at the infinity edge is very good, with good flow all along the infinity edge indicating pool is level.

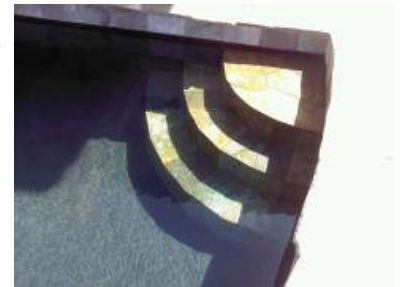
STEPS:

Two sets of steps at each end of the pool, with Quartzite tile. Steps appear in good condition, no chipping or cracks.

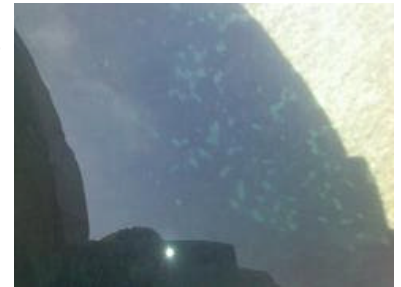
SURFACE:

Gray plaster surface. Age: Original = 23 years. Normal useful life for residential pools is 15-18 years. Expect re plaster in the next few years.

Appears satisfactory/serviceable for age, but with numerous surface wear spots, and several plaster chips.

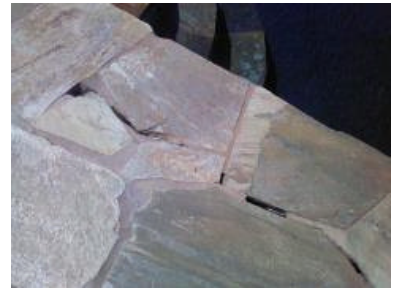
NOTE:

Drain holes in place all along the straight pool edge, to prevent pooling water.

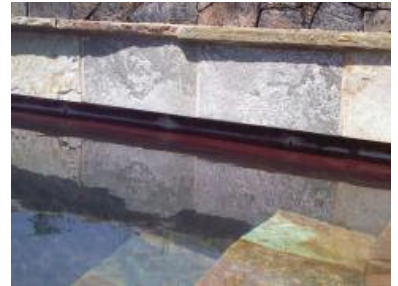
WATER LINE TILE:

Red "rojo" granite tile, nice quality. Note: White discoloration from water mineral build up, professional "bead blast" cleaning recommend.

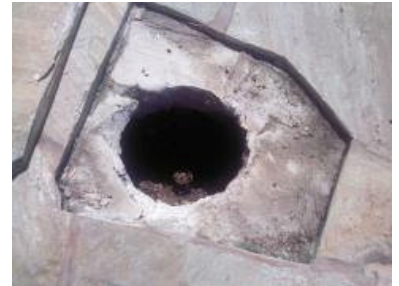
POOL MAIN SUPPLY VALVE:

The pool main supply valve is located under the deck, with a flagstone cap. The valve is frozen, and needs replacement.

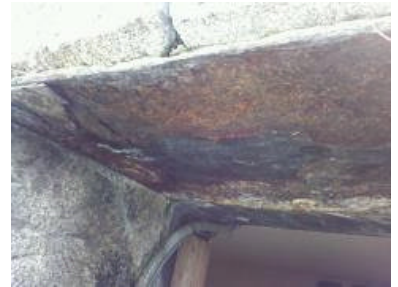
ENCLOSURE NOTE:

The equipment room entry /overhead steel span is very rusty. This will likely need a new type doorway support in the near future.

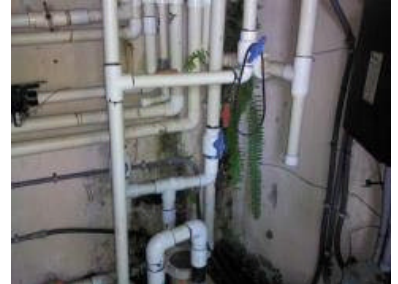
ENCLOSURE NOTE 2:

Some wall staining, mildew and moisture was observed at the south corner: Efflorescence seen on walls indicates the presents of moisture through the block wall.
I recommend clean the wall (and ground area), and apply a "Thoro Seal" type cement sealant to help keep the block walls from deteriorating.

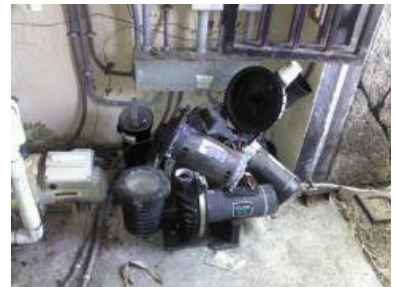
ENCLOSURE NOTE 3:

Remove and dispose of the old pumping equipment.

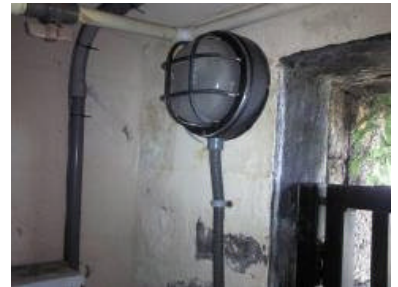
ENCLOSURE NOTE 4:

Pool Equipment room light is not working, likely need a new bulb.

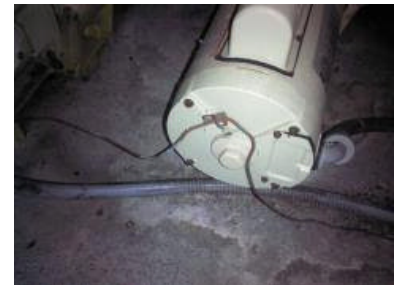
BONDING WIRE:

Bonding wire in place and satisfactory, connections OK.

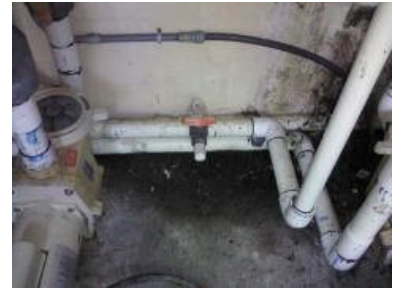
VACUUM / CLEANER:

Sweep motor has been removed.

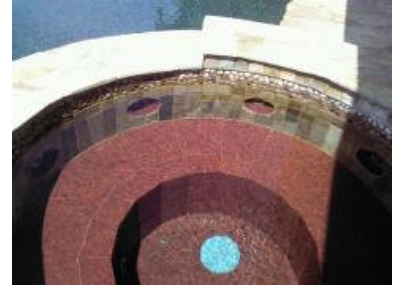
Red granite tile, and some Quartzite tile, with beach stone at the water line. Nice quality, and appears in good condition.

Appears in overall good condition, clean.

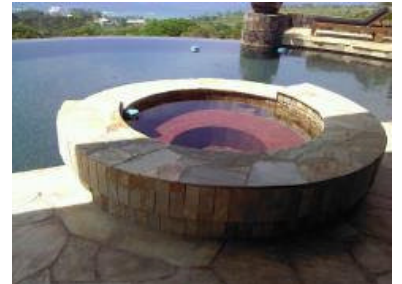
Concrete with Quartzite tile.

Good condition, no cracking or broken tiles noted.

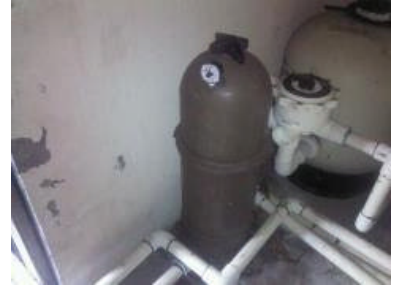
Cartridge type Appears satisfactory.

Hayward.

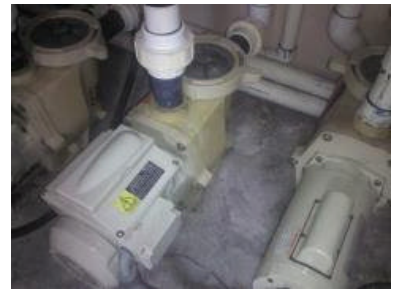
3 HP motor.

Newer, appears very good, replaced in 2011 as per disclosure. Motor runs smooth, no bearing noise, satisfactory.

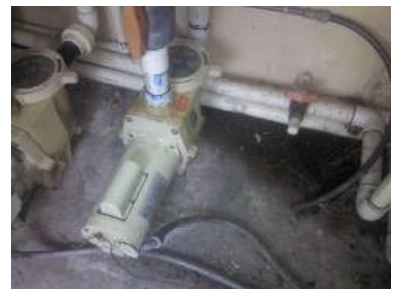
1.5 HP motor.

JET MOTOR/PUMP CONDITION: Newer, appears very good, replaced in 2011 as per disclosure. Motor runs smooth, no bearing noise, satisfactory.

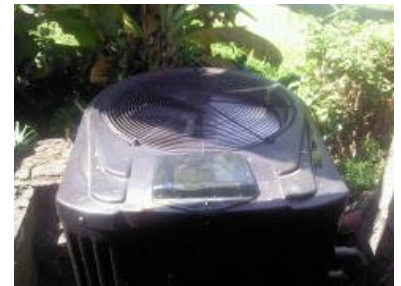
Electric Heat Pump.

Operational, good set up, appears in good condition, with a short test period.
