**Akamai Home Inspection Co. Inc.**  
P. O. Box 5397  
Kailua-Kona HI 96745  
329-5484  
akamaiinspection@hawaii.rr.com

**Report: 3Bd. 2 Ba Sample**

## **Confidential Inspection Report**

RE: Sunset Ridge - Waikoloa Village  
Waikoloa, HI 96738

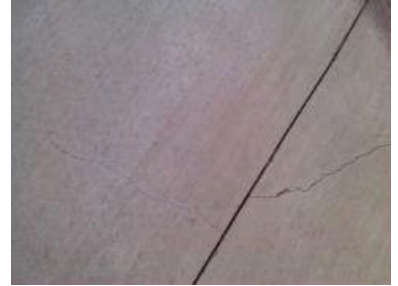
Good condition. Cracks noted are typical minor hairline type.

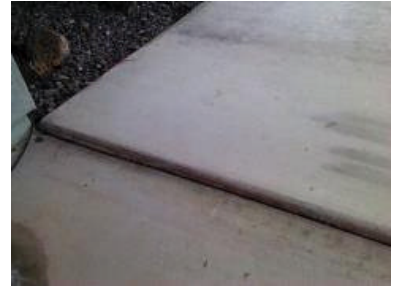
Tree root lift, Tripping hazard is present at the entry walkway section. Recommend removing the tree. Also, see roof report.

Overall, good condition. Cracks noted are typical minor hairline curing type. Tree root lift, Tripping hazard is present at the entry walkway section. Recommend removing the tree. Also, see roof report.

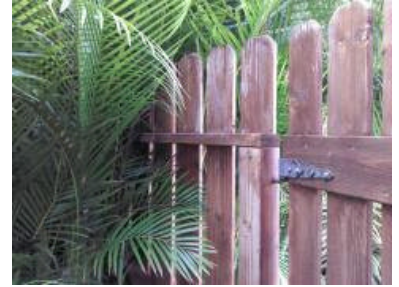
Satisfactory and good condition, secure. no moisture damage.  
Bamboo sealing will be needed in the future as preventive maintenance

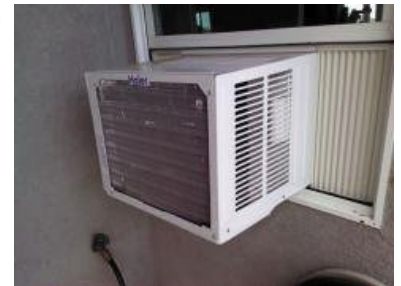
Operation satisfactory, some normal wear for age and location.

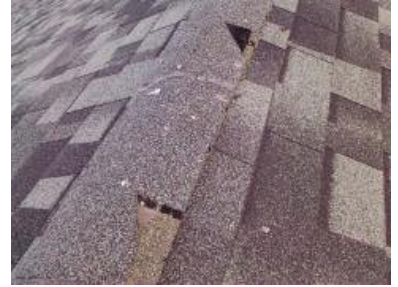
Comp Shingles at the hip and ridge caps, layout appears good. All Secure with a couple of damaged shingles, most likely from wind. Recommend replacement maintenance.

I recommend inspect the roof after heavy wind storms/gusts to see that no shingles are loose or torn. Any damaged shingles can be nailed and glued with roof mastic to secure to the plywood roof decking.

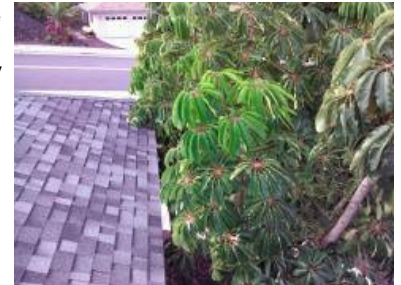
The trees need to be cut back and away from the roof and structure. Tree branches will damage the shingles, drip edges and fascia during windy periods.

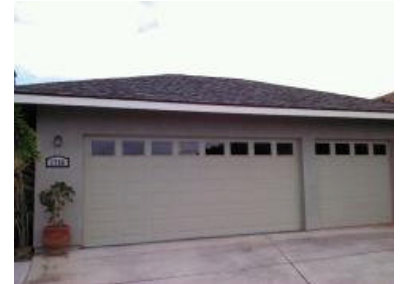
Three car with wall separating the two spaces.

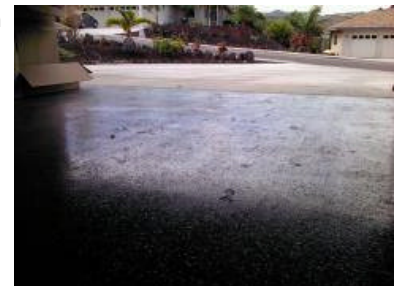
Good Slope for proper drainage. Grade drains in place to divert runoff away from the structure, good set up and condition.

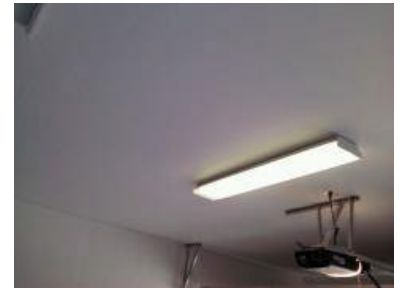
Operational, Good Fixtures.

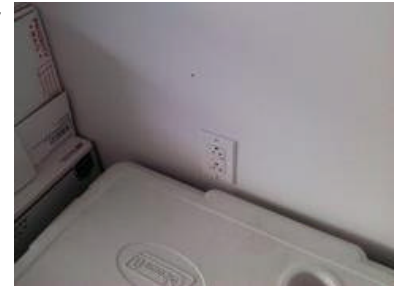
Outlet has power and is grounded. GFCI safety outlet trips properly, reset is satisfactory, resets at wall outlet.

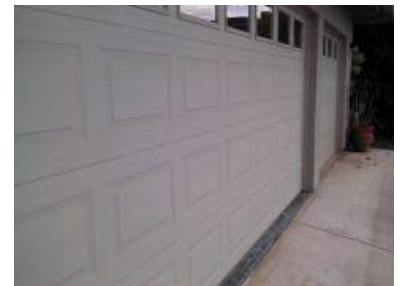
Single and Double car access door. Overhead roll up, Insulated aluminum panels at the double door.

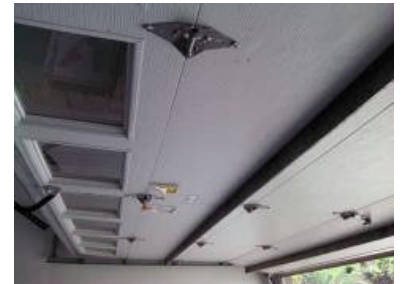
Operation and condition is good, hardware is operational and satisfactory. No excessive wear or damage noted.

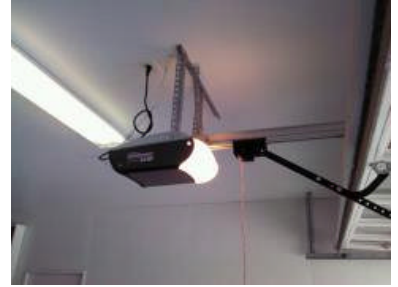
Automatic door opener is - operational, Automatic reverse is operational.

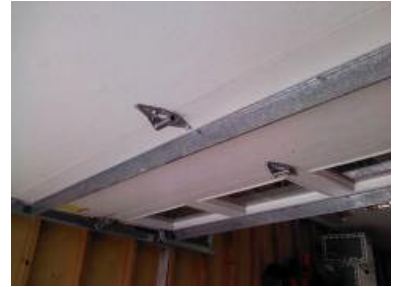
Single door, Manual operation is good.

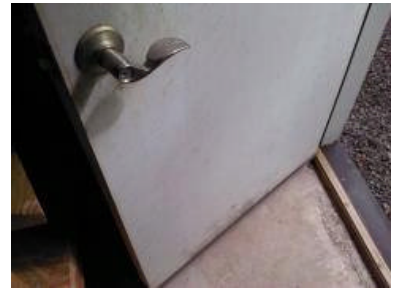
Satisfactory.

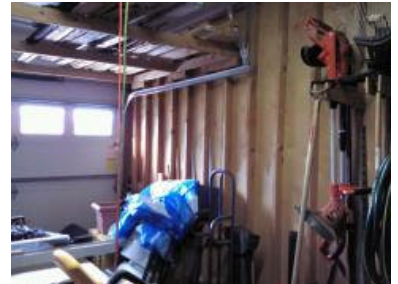
Single garage side is enclosed and used as a work shop. All appears solid and in satisfactory condition. This wall can be removed if needed.

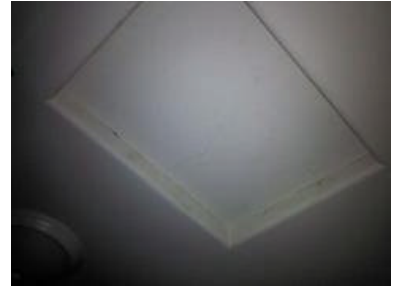
Hatch location: Garage and master bedroom closet.

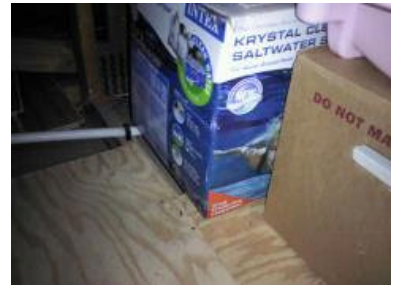
Possible Storage - The attic cavity has the capacity for storage of light boxes or items, with the addition of flooring over joists.

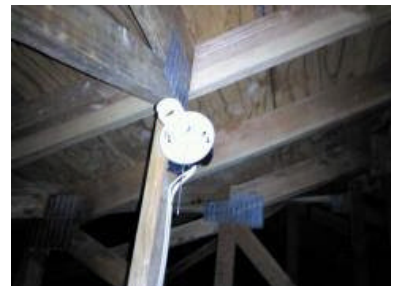
Functional, switch operational.

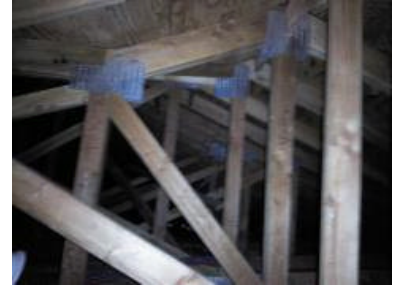
There is no evidence of current water leaks into the accessible attic spaces. Interior living area ceilings are clean. No water stains at ceilings.

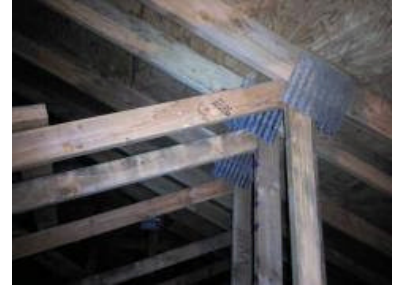
Manufactured trusses, 2x6@24" on center.

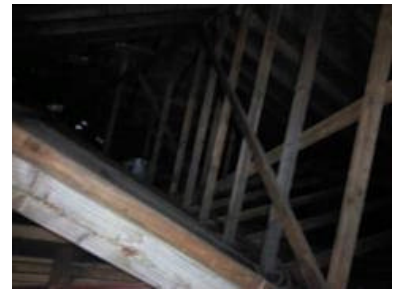
A truss system is installed in the attic cavity that is used to support the roof decking and transmit the roof load to the exterior walls. The truss spacing is 24 inch on center.

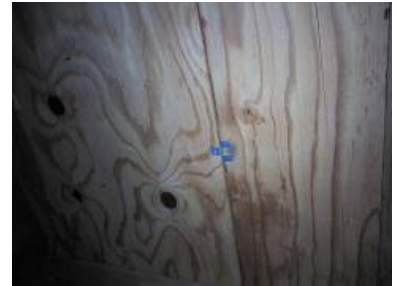
The roof decking material is plywood sheeting. The builder installed ply clips when installing the sheeting to prevent the sheeting from sagging at the joints.

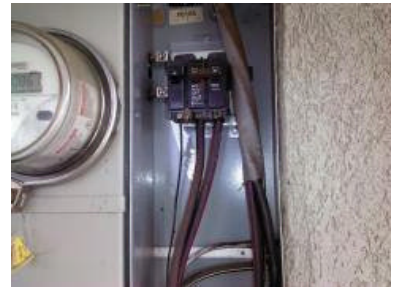
Appears satisfactory and serviceable. Layout and condition good. Main Breaker appears satisfactory.

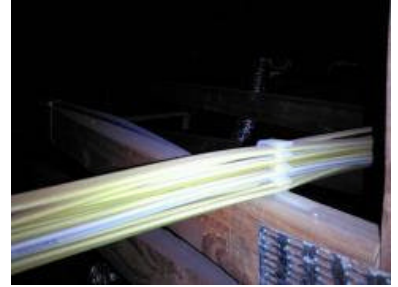
Plastic Shielded. Visible sections of wiring appear satisfactory.

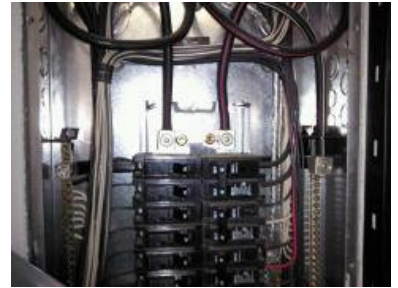
Panel front condition is satisfactory, Layout and condition is very good, clean within the panel housing. All copper wiring at 110V circuits, No loose wires and no evidence of any arching. No visual evidence of excessive heat, or heat related damage. No double taps at circuit breaker lugs.

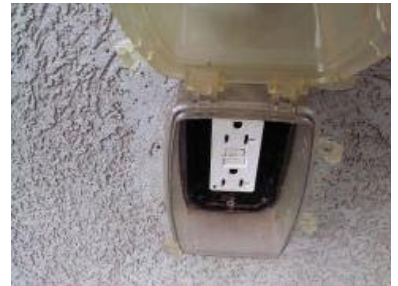
Exterior outlets are satisfactory and in serviceable condition. GFCI outlet is operational, Proper exterior outlet covers in place. Exterior lights are functional.

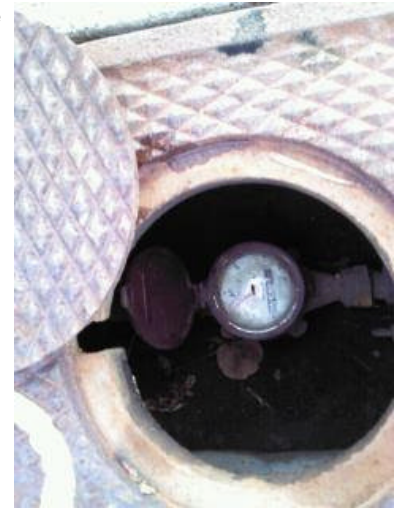
*LOCATION:* Water meter is located: at the east side of the driveway, at the road lot corner.

*WATER METER FLOW DIAL:* The Flow Dial at the water meter is dead still, indicating no leakage within the house plumbing system.

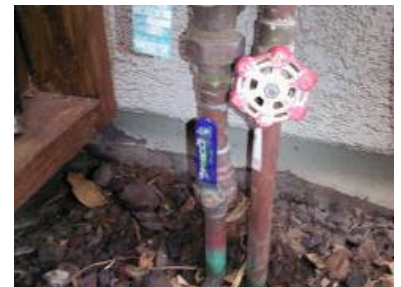
*LOCATION* Main house Shut Off Valve is located: East side and outside garage.

*CONDITION* Valve is operational, good condition.

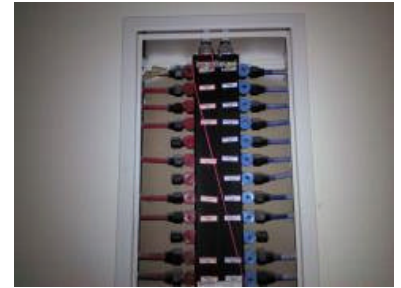
Water supply line grade plastic (Pex), Vanguard Manifold system. Manifold Location: Laundry room. Manifold cover door is satisfactory.

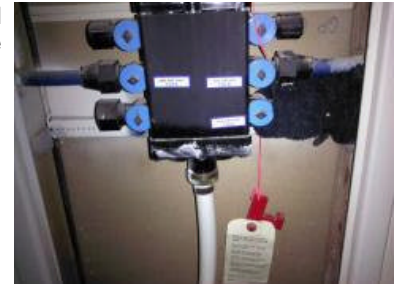
Visible sections appear satisfactory and serviceable. All water shut off valves are at the Manifold.

Note: Manifold valve key is in place.

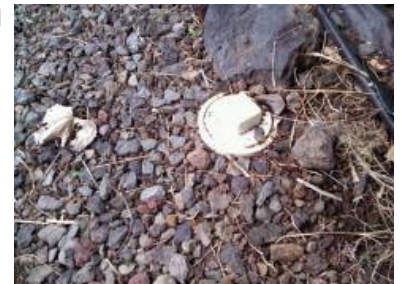
Visible sections appear satisfactory and serviceable. Clean outs covered.

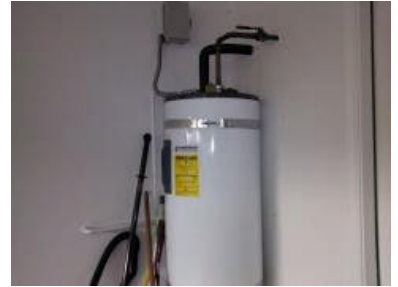
Good condition and operation, Good setup, No Rust.

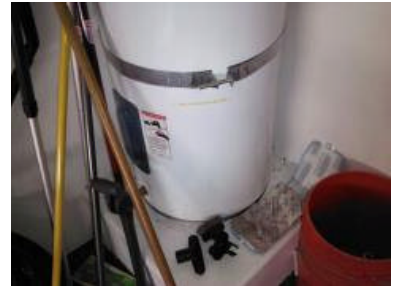
Security strapping in place and satisfactory.

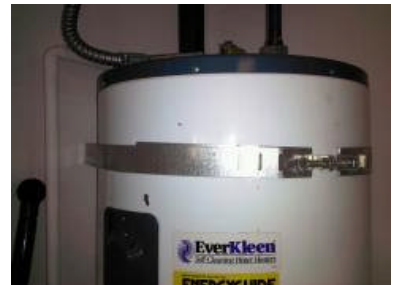
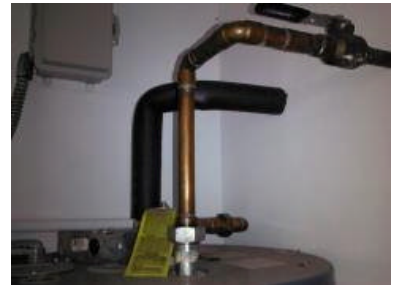
Shut off valve, operation and condition is good. Plumbing connections are O.K., no corrosion. Pressure relief valve.

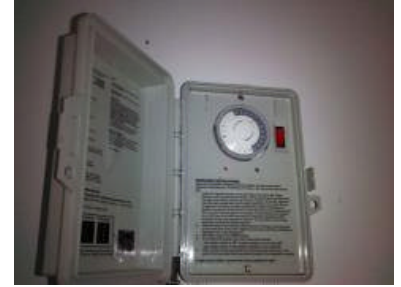
GE. Appears operational.

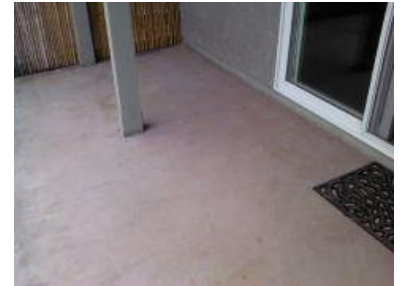
Condition is satisfactory. Hairline cracks are typical, hairline curing cracks.

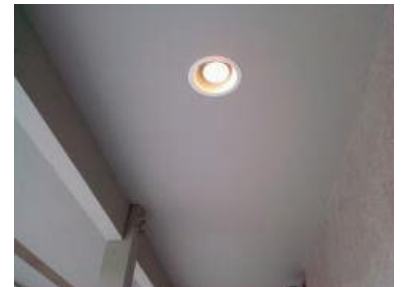
Lights are operational. Switched at the dining, kitchen and master bedroom.

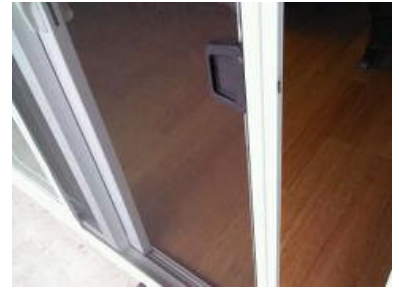
All screen doors appear to be in good condition.  
Slide well.

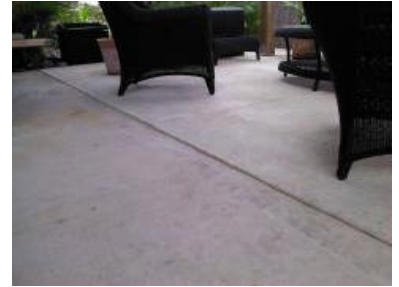
Good slope away from the structure.

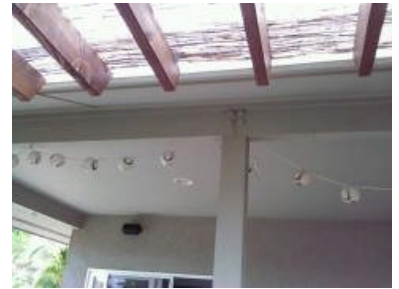
Satisfactory and good condition, the cover is clean.

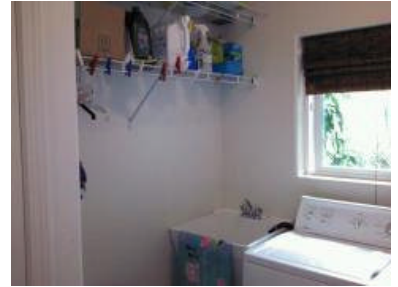
Plumbing appears O.K. No Leaks or moisture damage noted. Electrical outlet is grounded, 110V circuit in place-operational, 220V circuit in place, Service-operational.

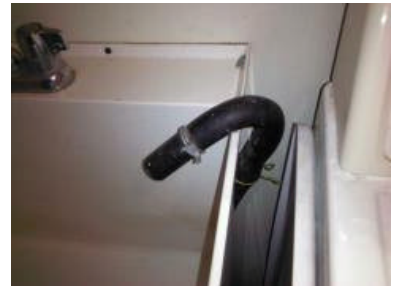
Drain line is at Sink. Hose is loose, needs securing (string or cable ties work well).

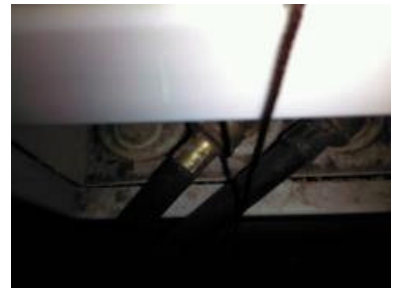
Supply valves appear O.K. No leaks or major corrosion.

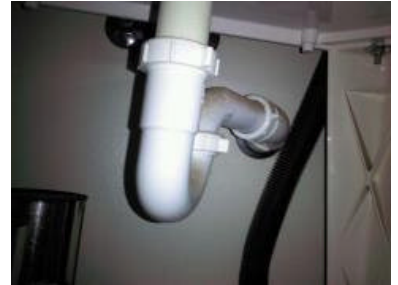
Laundry sink is satisfactory, sink and plumbing are in good condition. Clean and dry under sink. Hot & Cold OK. Sink is secure at the wall.

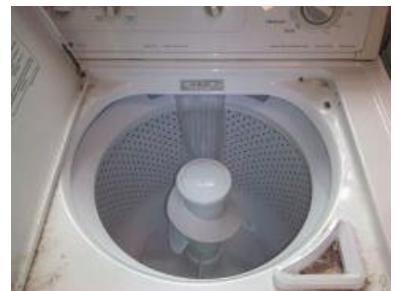
*CLOTHES WASHER CONDITION:* Appears satisfactory, clean, operation good.

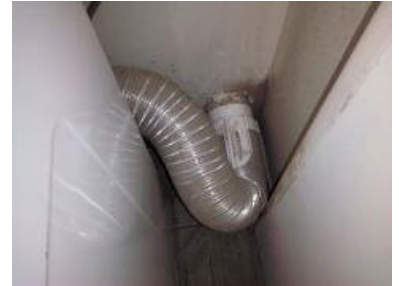
Dryer venting is provided through wall, through attic to exhaust at roof. Vent hose is in place and connected, and appears in good visual condition.

Appears satisfactory, At roof, I recommend periodic inspection of the dryer vent duct as preventive maintenance.

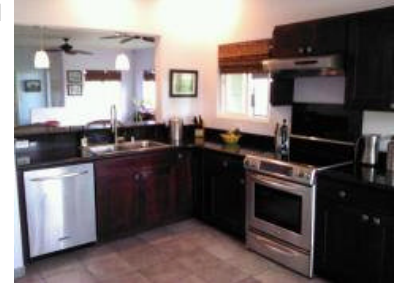
Kitchen with a serving counter is clean and in good condition. Designed with good quality components and fixtures.  
All stainless steel appliances in place.

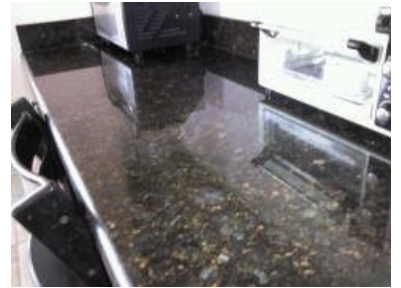
Appear satisfactory.

To prevent water stain damage to granite counters; Granite sealer and polish maintenance is recommended as a preventive maintenance program. Cantilevered extension at kitchen serving counter designed with no visible bracing, appears satisfactory.

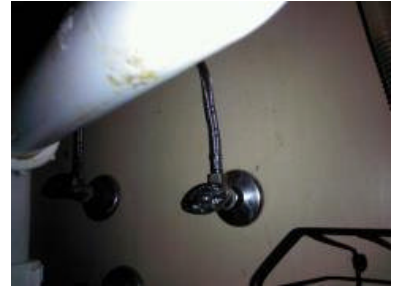
Plumbing condition is good. Dry and clean under the sink. No leaks noted or present at time of inspection with water flow testing at the supply valves, lines, at both sink connections, sink traps or waste lines.

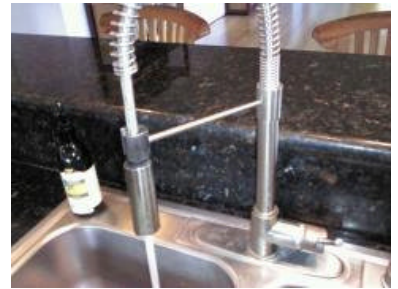
Pull out with sprayer feature, Swivel, Faucet: is satisfactory and in good condition. Hand sprayer is:

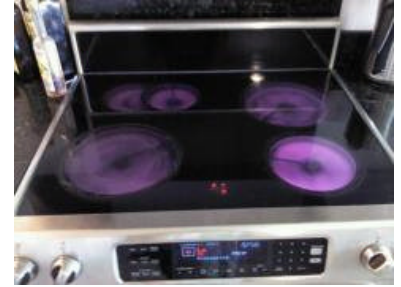
Operational and appears satisfactory, some normal surface wear for age.

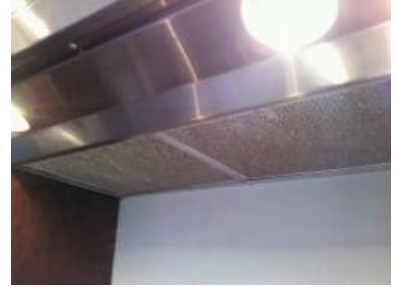
Fan/Hood operational and in good condition. Switches functional, Filter in place and condition O.K. Light operation O.K.

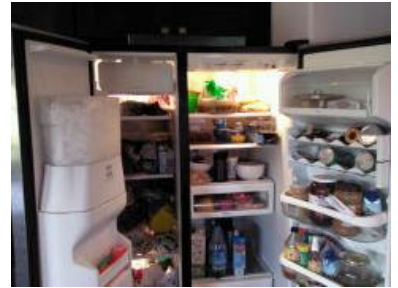
Appears satisfactory and in good condition, cold inside. Appears satisfactory, cold inside, and in good condition for age. Shelves and drawers in good condition. Door gaskets are satisfactory, and clean.

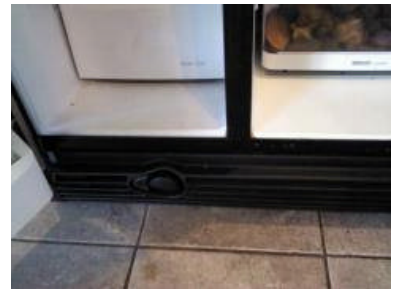
Dry under and around the appliance. Dry under the bottom drawers. No condensation, leaks or moisture noted under refrigerator at time of inspection.

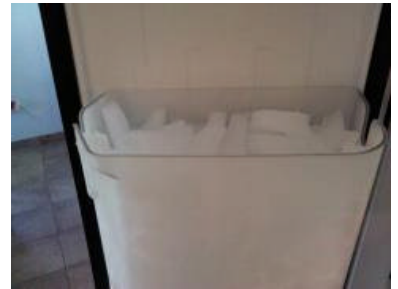
Operational and good condition.

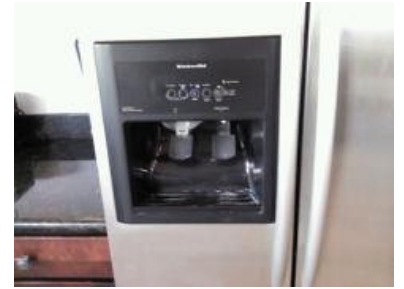
*ICE & Water DISPENSER:*

Water and ice dispenser are functioning correctly.

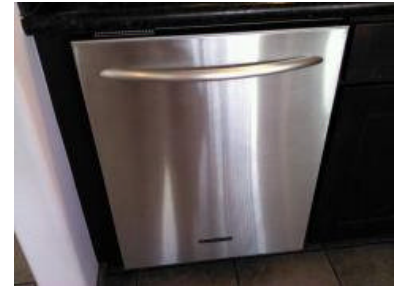
**DISHWASHER:**  
*BRAND*

Kitchen Aid.

Appears satisfactory, operational and in good condition. Baskets in good condition, no rust.

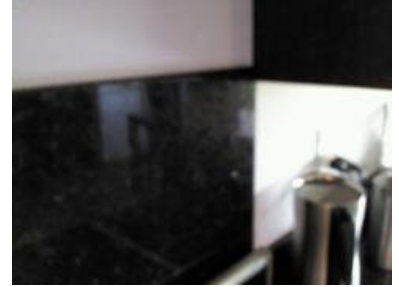
Drywall with granite Splash/Surround. Walls are in good condition.

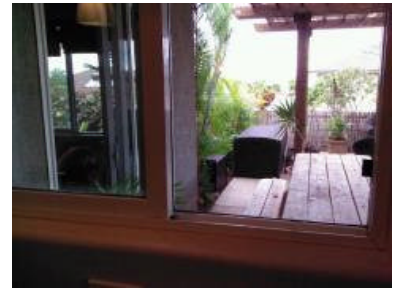
Window operation is O.K.

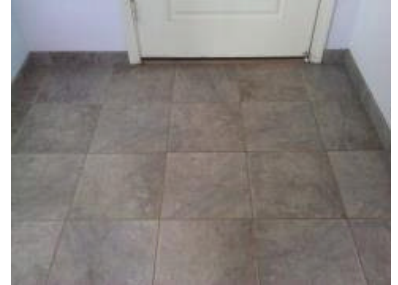
Flooring O.K. Porcelain Tile, Light fixture: operation is good.

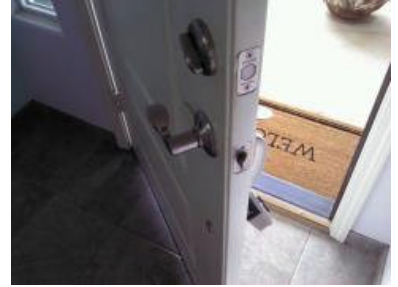
Satisfactory, hardware in good condition. No corrosion. Weather stripping is in place, OK. Latch and handle and dead bolt are O.K.

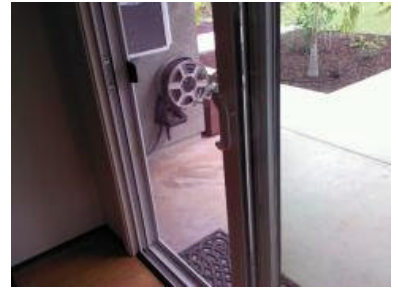
Satisfactory, hardware in good condition. No corrosion, Track and frame are satisfactory. Doors are easy to operate, slide well.

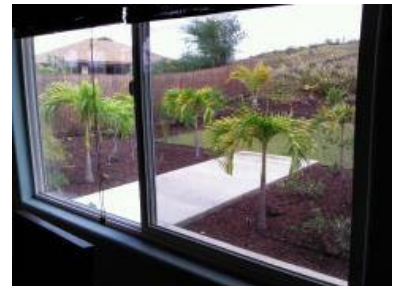
All double pane windows and sliding glass doors were checked, and are clear and without discoloration at time of inspection.

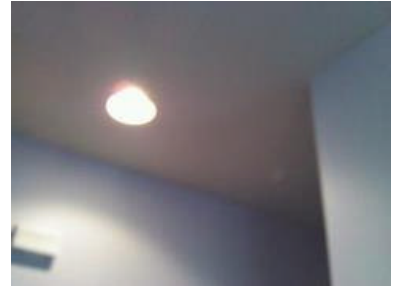
General condition appears clean and satisfactory, no cracks or moisture staining noted.

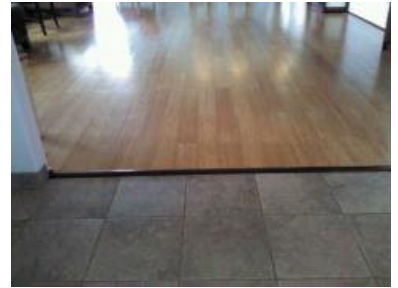
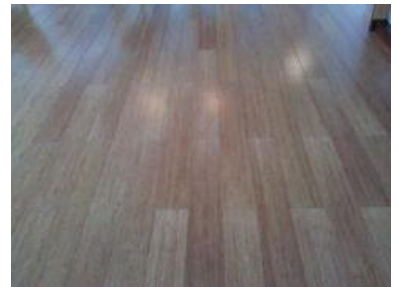
Layout and condition of tile is good, Tile taps solid, with random tap test. Good quality bamboo flooring, overall good condition.

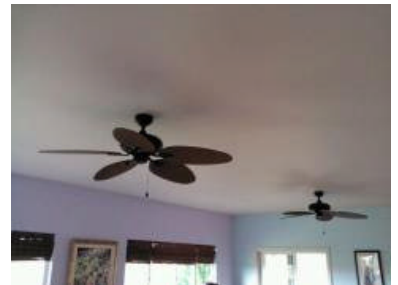
Appear to be in good condition, both fans are operational.

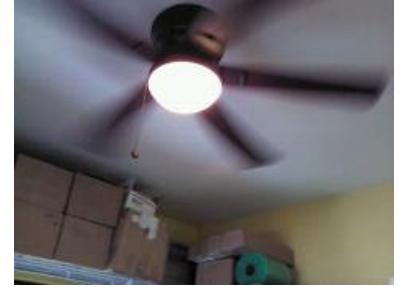
Lights are operational, Switches and fixtures are operational and in good condition.

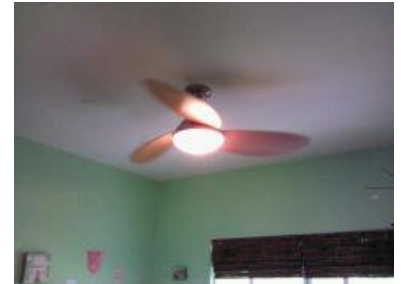
Outlets are functional.  
Fans OK, Operational and balanced.

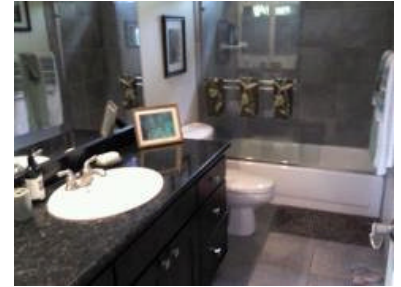
Bathrooms are clean and in good condition. Designed with good quality components and fixtures.

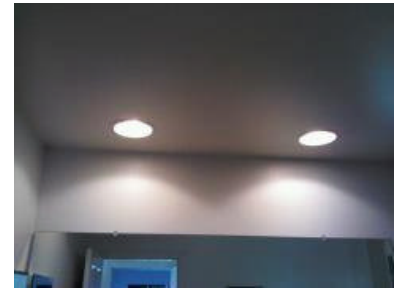
Lights, outlets, and switches are operational. GFCI safety outlets test O.K. Resets at wall outlet.

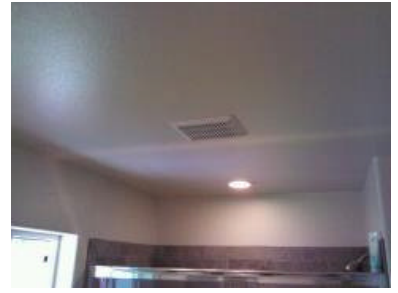
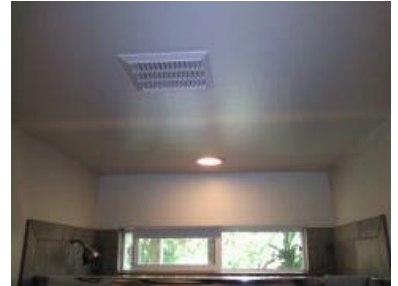
Condition of ceilings are good, no moisture stains.

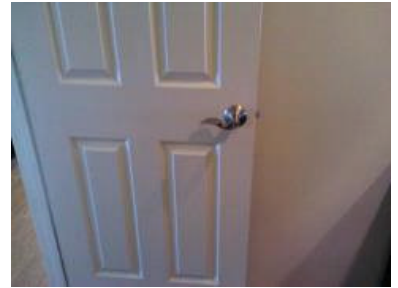
Condition and operation are good. Door stops in place and functional.

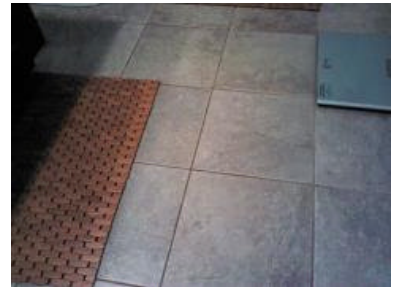
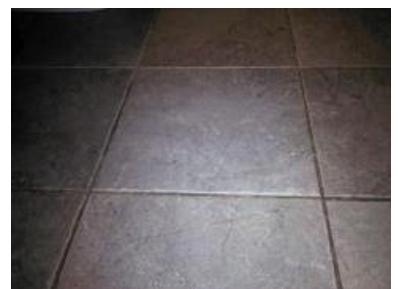
Flooring is in good condition. Good quality, Tile flooring taps solid, condition O.K. No cracked or broken tiles noted.

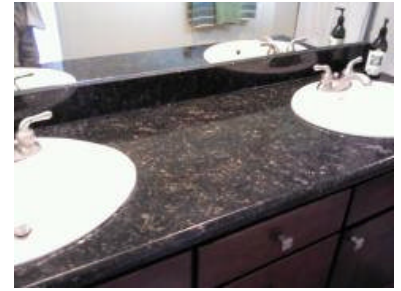
Porcelain, Double sinks, at master bath.

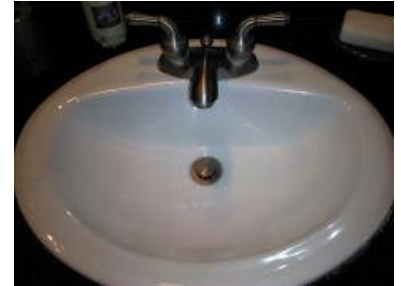
Sink conditions are good, appear satisfactory. Drainage is satisfactory.

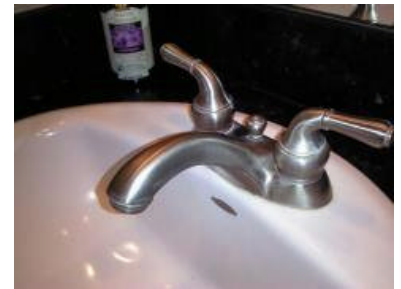
All faucet operations are good. Drain stoppers: operation is good.

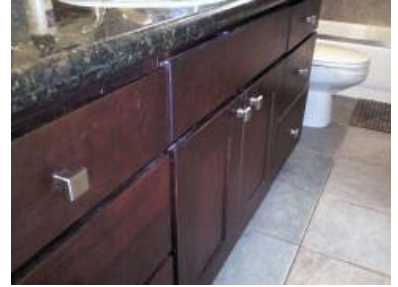
Cabinets are satisfactory and in good condition. Cabinet hardware is operational and in good condition.

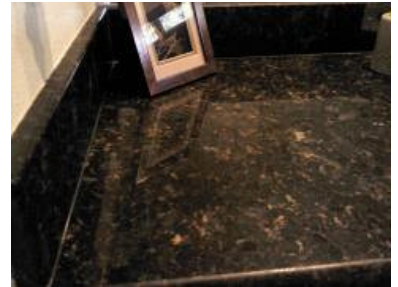
Condition is good, no defects noted.

Note: To prevent water stain damage to granite counters, Granite sealer and polish maintenance is recommended as a preventive maintenance program.

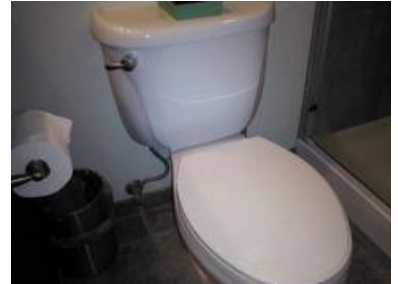
Toilets are satisfactory and operational. No leaks noted at supply valves, tubing, or tank connections. Toilets are tight to the floor.

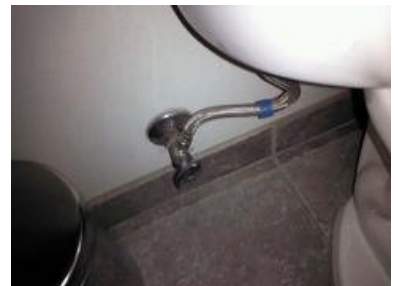
Supply valves are: operational and in satisfactory condition.

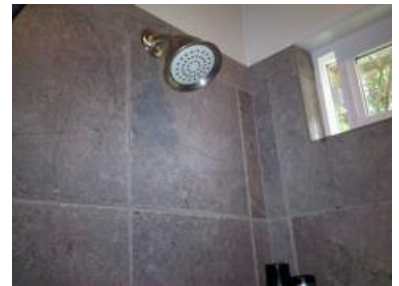
Tub and shower areas appear satisfactory. Tile appears good, taps solid. Tub shower walls are in good condition, no cracked or missing tiles, no tiles loose at walls.

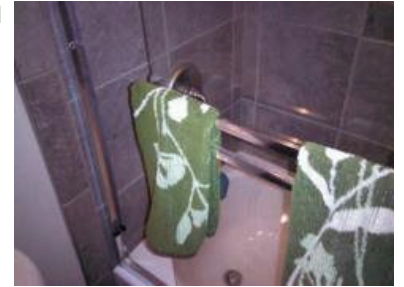
Glass door enclosure is operational and in good condition.

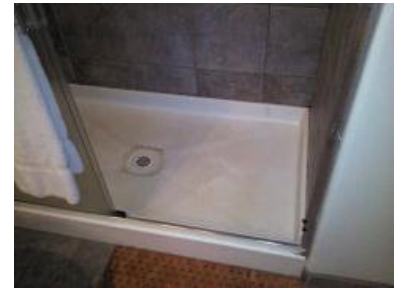
Step in type shower, appears satisfactory. Clean and in good condition.

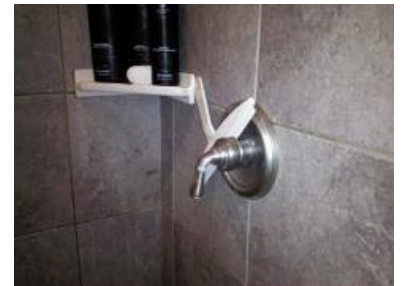
SHOWER PLUMBING FIXTURES: Fixtures are satisfactory and hardware is in good condition. Drainage is normal and adequate. Shower head appears satisfactory.

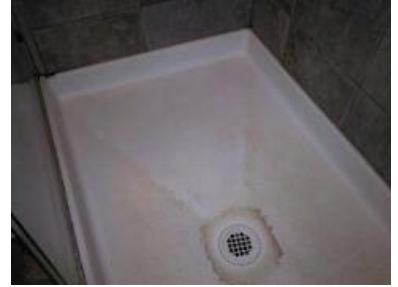
Fiberglass shower pan, condition satisfactory. Could use cleaning.

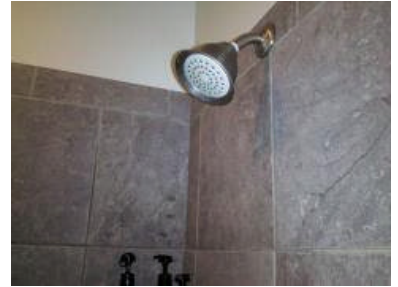
Shower areas appear satisfactory. Tile appears good, taps solid. Shower walls are in good condition, no cracked or missing tiles, no tiles loose at walls.

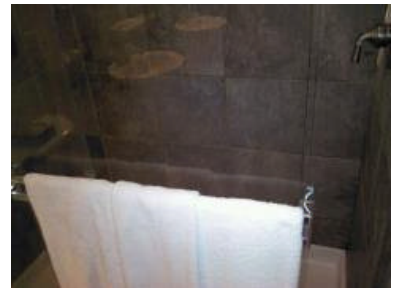
Glass door enclosure is operational and in good condition.
